# PROBLEMS, CAUSES, AND CURES

Technical Publication No. C200 • Revised © 2018 | 3rd Edition

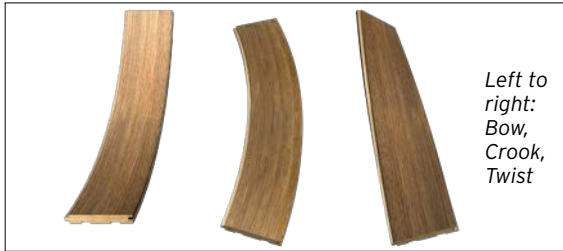
**DEFINITION:** Any variation of the intended shape of a piece of wood flooring from a true or flat plane.

**Bow** - A deviation in the lengthwise flatness of a board, measured end to end.

- Solid wood flooring: Bow occurs when one side of the floor board shrinks more in length than the other. It causes the lengthwise curvature of the plank that resembles a bow used in archery. Because longitudinal shrinkage in solid wood is minimal, bow is normally not an issue that affects installation.
- Engineered wood flooring: Bow occurs when the wear layer and the core begin to shrink in opposing lengthwise directions, forcing the uninstalled planks to bow. Manufacturer and industry standards (HPVA) dictate tolerances and milling requirements for the amount of bow allowed in an engineered wood floor at the time of manufacture. This may or may not coincide with uninstalled flooring at the jobsite due to change in moisture content as a result of jobsite conditions.

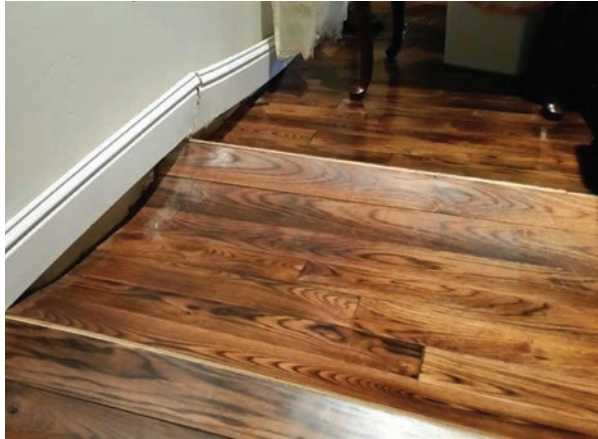
**DEFINITION:** The wood flooring has separated or lifted from the subfloor.

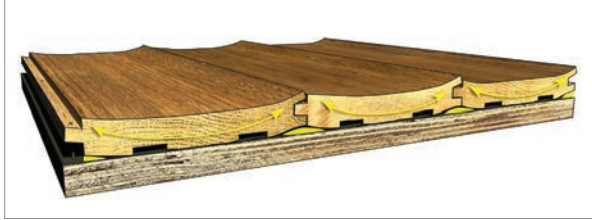
**DEFINITION:** A concave or dished appearance of individual boards with the edges of the board raised higher than the center. This is also a type of warp.

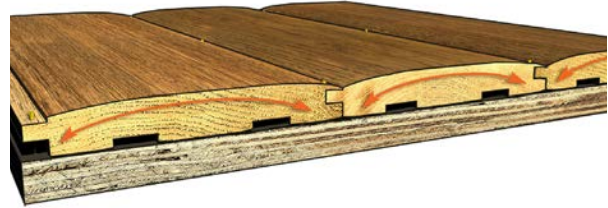
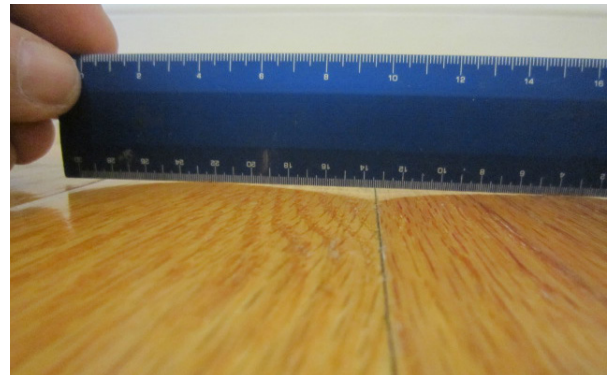
**DEFINITION:** A convex or crowned appearance of individual boards with the center of the board higher than the edges. This can also be a type of warp.

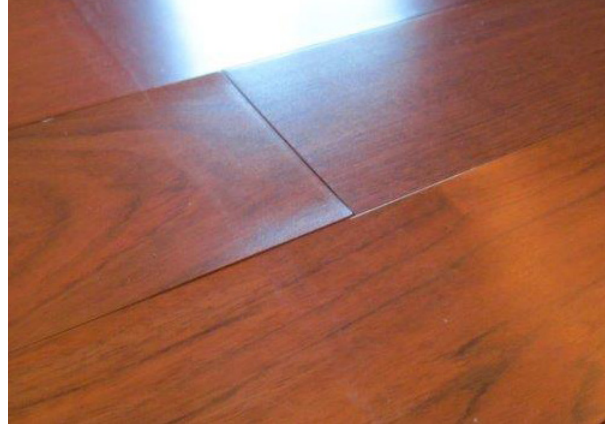
**DEFINITION:** A concave or dished appearance of individual engineered flooring planks with the edges raised higher than the center.

- When relative humidity levels remain below the manufacturer's recommendations for long enough, engineered planks can begin to dry cup. When this happens, the wear layer loses moisture and begins to shrink across its outer face, which can exert enough force on the core material to pull the edges of the plank (often the groove side) upward. This causes a cupped appearance across the width of the board.

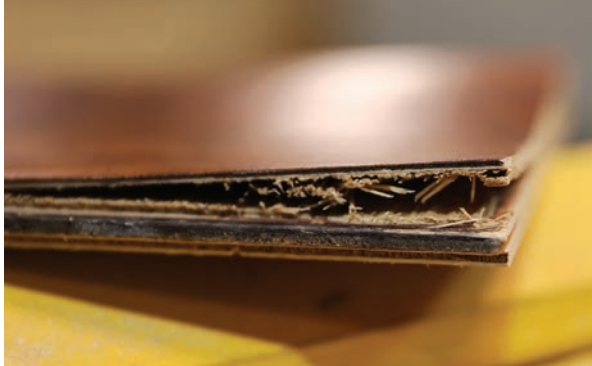
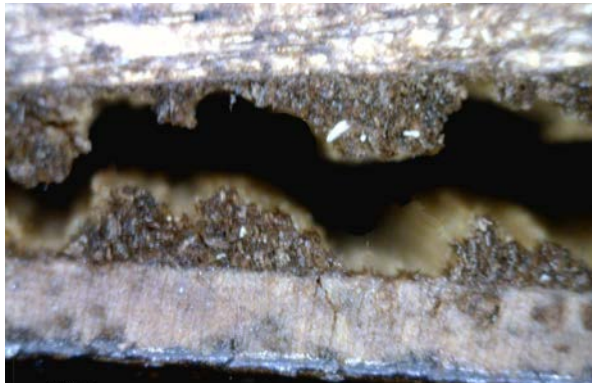
**DEFINITION:** External stresses exceeding the strength of the wood fibers within an individual plank of engineered flooring, resulting in the wood fibers being torn apart. When examining this type of failure in an engineered wood flooring plank, wood fibers will be visible at the point of separation, remaining bonded to the adhesive layer.

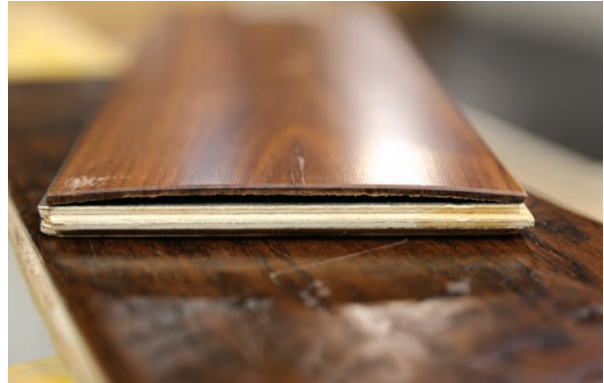
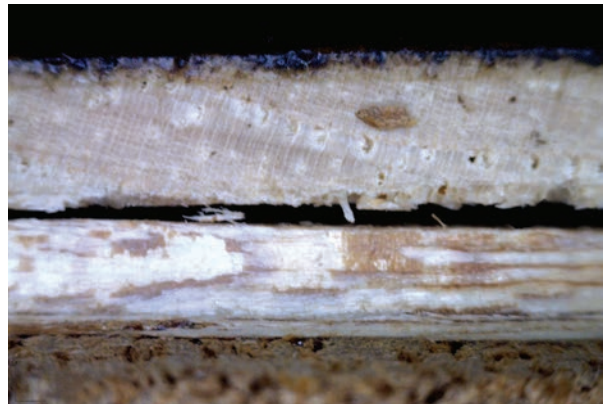
**DEFINITION:** Engineered flooring is manufactured by adhering several layers/plies together. The separation of two layers/plies within a piece of engineered flooring due to the lack of an adhesive bond is typically identified as a clean separation at the glue-line. Adhesive bond failure is unrelated to inadequate relative humidity levels.

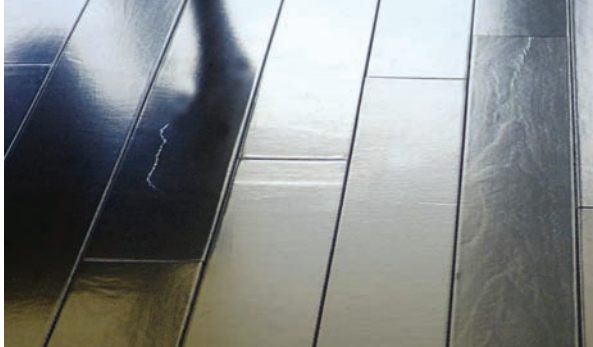
**DEFINITION:** Visible patterns on the surface of the wood floor plank that resembles variations in the engineered flooring core material.

- A gain or loss in moisture, causing wood fillet/finger block core materials to change dimension, which can then telegraph to the surface of the plank.
- Skips, voids, missing/open knots, or overlaps within the core material, that telegraphs to the surface of the plank.

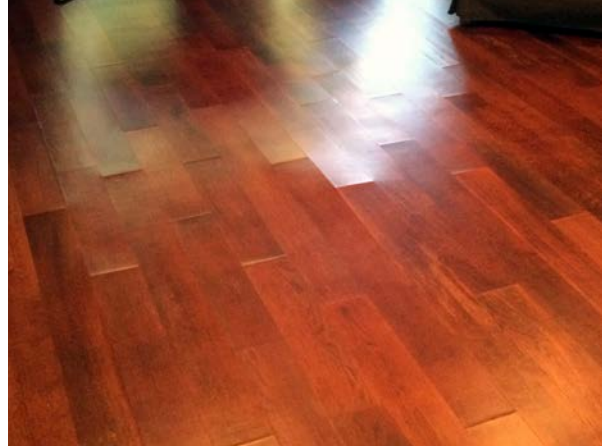
**DEFINITION:** A condition where the ends of installed engineered wood flooring boards deviate from the flat plane and appear raised or curved upward.

- Flooring incompatible with the environment in which it is installed.
- Engineered flooring that has experienced an increase in moisture, where the core material running perpendicular to the face of the board swells at a different rate and in a different direction than the adjoining layers, forcing the ends of the material to lift, which can then telegraph to the surface of the plank.

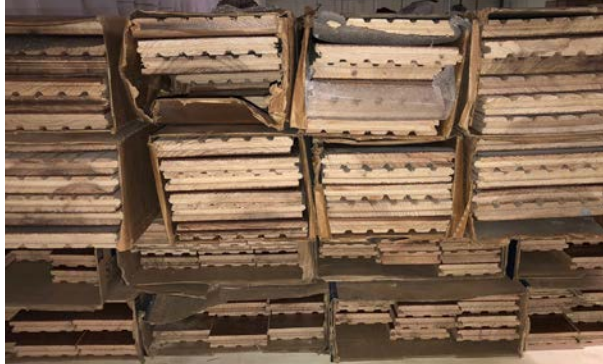
**DEFINITION:** A condition where the ends of solid wood flooring boards deviate from the flat plane and/or parallel plane, and may appear wider or thicker than the rest of the board.

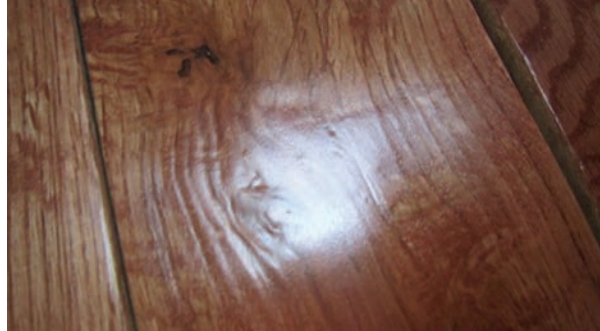
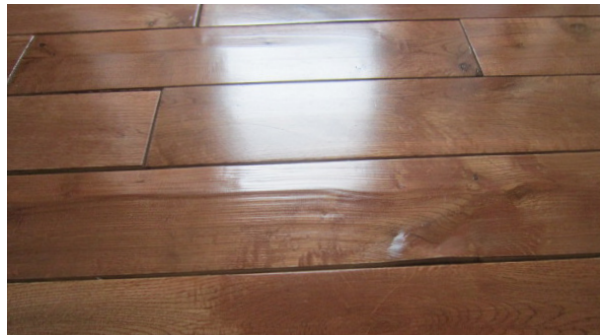
**DEFINITION:** Natural and unique features, properties, and growth patterns in wood that cause it to appear and perform non-traditionally, resulting in distortions from non-uniform swelling and shrinking.

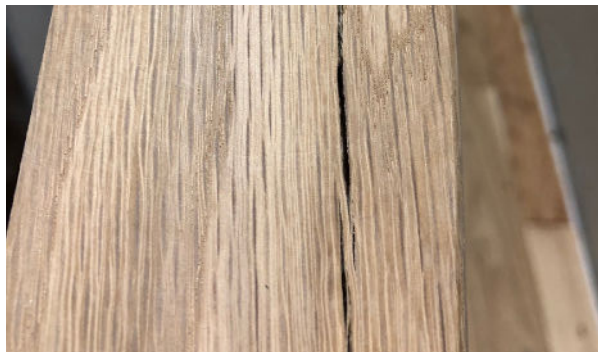
**Surface-Checks** - Surface checks are separations in the wood fibers that usually occur in, or adjacent to, the wood rays on the faces of plainsawn (flatsawn) boards. These separations occur during the early phases of the drying process where the external and internal stresses cause the wood to tear itself apart.

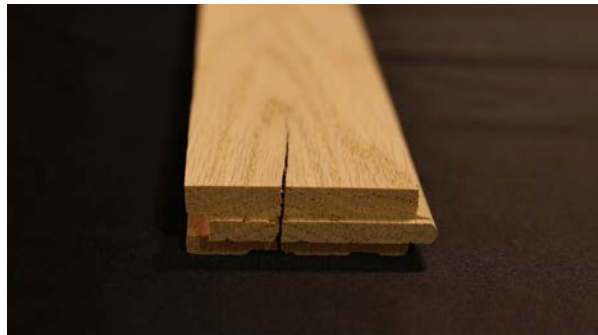
**End-Checks** - Like surface checks, end checks occur in, or adjacent to, the wood rays, but on the ends of the boards rather than the face. These separations occur due to the normal movement of moisture along the length of the boards, where the ends of the boards dry more rapidly leading to stress fractures on the ends of the boards.

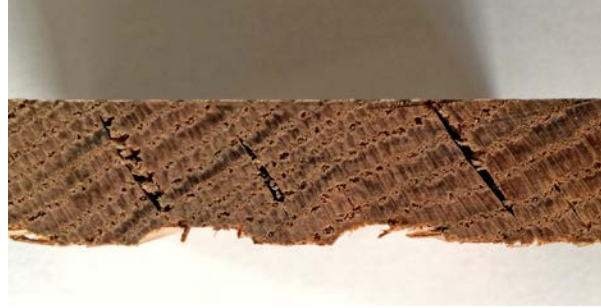
**Internal Checks (Honeycomb)** - An internal defect in the wood that may not be visible on the surface of the board, but occurs in the core (inner part of the board) of solid boards. These checks can become exposed when the boards are sanded or milled. They can also become exposed on the surface of the board with a loss in moisture or changes in RH after installation.

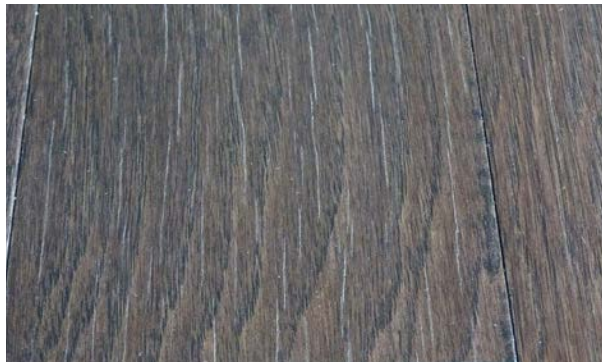
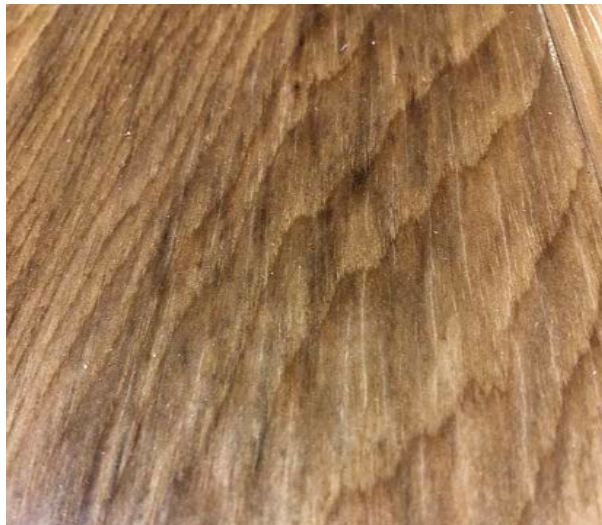
**DEFINITION:** In engineered flooring with rotary peeled or sliced face veneers, as the knife separates the veneer from the log, the separated sheet of wood is laid flat where stresses can occur in the region near the knife edge. If the strength of the wood is exceeded, this stress is relieved by separations (or checks) of the wood fibers parallel to the grain of the veneer at the knife edge. The knife edge of the veneer is known as the open (or loose) side, and the opposite side of the veneer is known as the closed (or tight) side. Lathe checks are not normally visible on the face of the finished board.

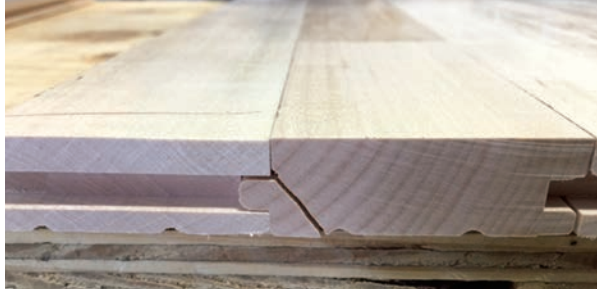
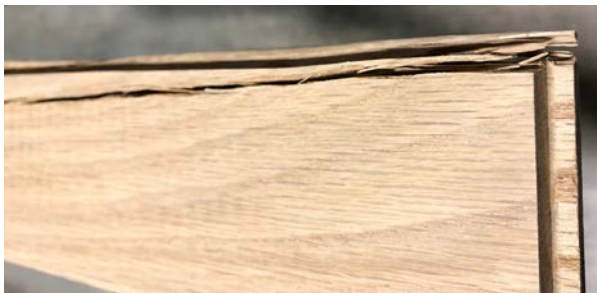
**DEFINITION:** A tearing apart or rupturing of the wood that may run at various angles to the growth rings.

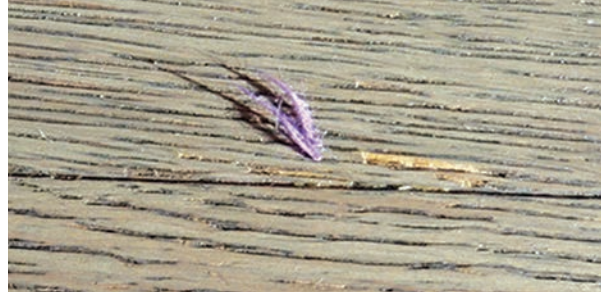
**DEFINITION:** Sharp fragment of wood separated/fractured away from the edge or face of the board protruding from the floor.

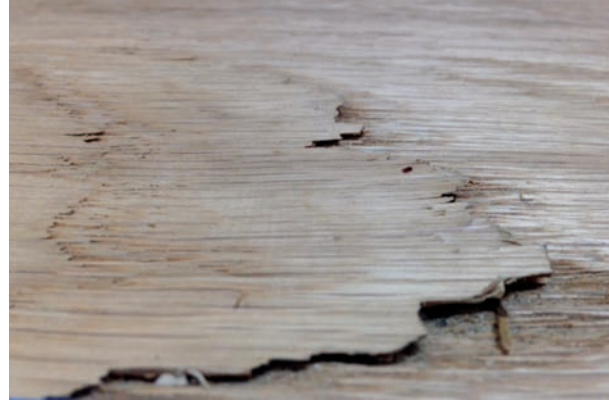
**DEFINITION:** A separation of the wood's fibers along the grain (parallel to the growth rings), that usually occurs between the rings of annual growth.

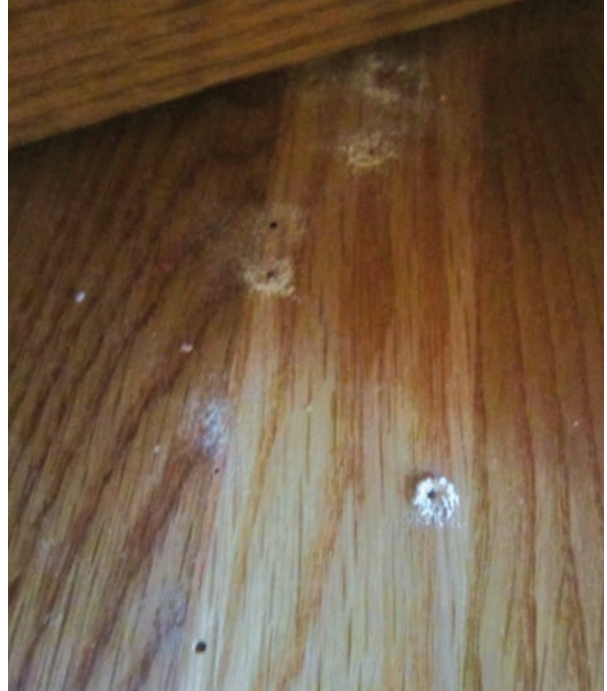
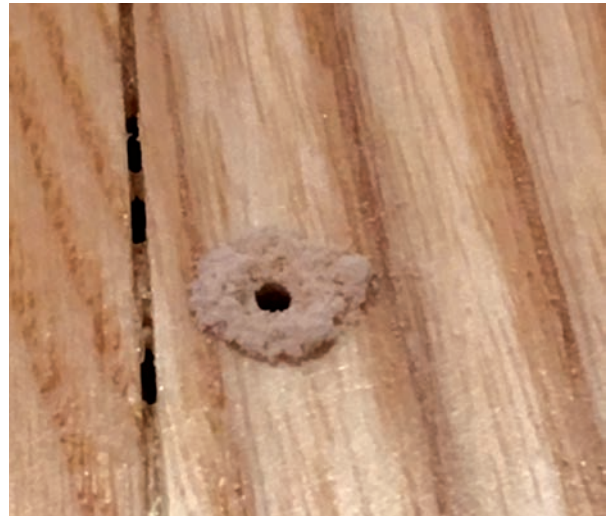
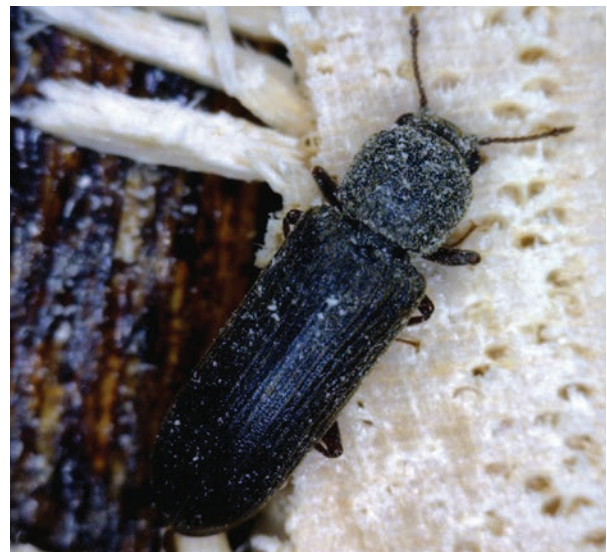
- **Powderpost (Lyctid/Anobiid) Beetle** - The larvae of wood-eating insects bore in and feed on the wood fibers causing damage to both hardwoods and softwoods. Properly kiln-dried lumber will normally eliminate powderpost beetles, but infestations can occur at any point after the kiln-drying process, including during storage, transport, or from other wood products.

- Infestation often occurs long before, but can even occur after the wood floor is installed. Female beetles lay their eggs within the pores of the bare, unfinished wood. The larvae feed on the wood, creating tunnels that fill with a powdery substance called frass. Later, when the larvae mature, they exit the wood, creating small pinholes, generally measuring 1mm-3mm (1/16"). In active infestations, the holes will be surrounded by this frass (light-colored powder). This frass material is very fine and will feel like talcum powder when rubbed between two fingers. The presence of an actual beetle, beetle larvae, or frass is the only way to absolutely confirm an active infestation.

- Improperly dried or stored lumber.
- Lyctid Powderpost Beetles are usually brought into the house in wood products that contains eggs or larvae that may have been in furniture, firewood, untreated reclaimed lumber, joists or framing, molding, trim, wood paneling, cabinets, or even the pallets used to transport the flooring.
- Termites and Anobiid Powderpost Beetles normally prefer to infest wood that is damp; therefore, infestations usually begin in moist, poorly ventilated areas such as in unconditioned crawl spaces or basements.

- Removal and replacement of the affected wood.
  - In the rare case of severe, widespread infestations, when insects have spread into walls, between floors, or other areas where access/ wood removal is impractical, structural fumigations may be necessary.

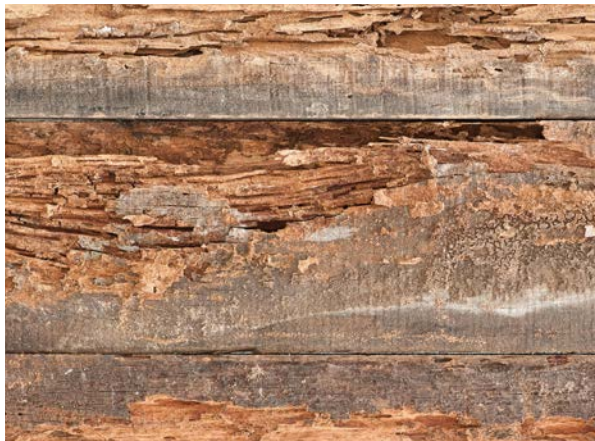
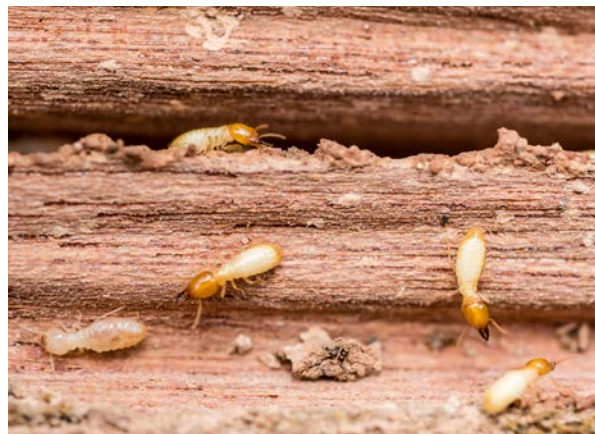
- **Termites** - Termites are attracted to areas where moisture accumulates in and around your home, including damp basements, laundry rooms, bathrooms, and leaky foundation walls.
  - Termites will eat any kind of wood including mulch, rotting wood, new wood, painted wood, and treated wood.
  - Stagnant, moist air in the home provides the perfect breeding ground for termites.
  - Termite-damaged wood is usually hollowed out along the grain, with bits of dried mud or soil lining the feeding galleries. Wood damaged by moisture or other types of insects will not have this appearance.
  - Termite infestations are a site-specific condition.

- Reduce and maintain moisture levels below 12% in and below the floor.
- **Termites:**
  - Termite treatment should be conducted by a professional. The company should be licensed by the Department of Agriculture or agency responsible for regulating termite control in your state. The treatment professional may use one of two general categories of termite treatment, liquids or baits.

- Since termites require wood with high moisture content, correction of the moisture source is necessary.
  - Structural damage should be repaired. Damaged flooring should be removed and replaced.

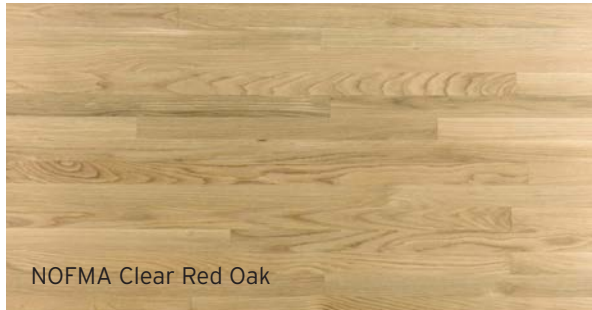
NOFMA Clear Red Oak

**DEFINITION:** A discrepancy in the designation of the aesthetic appearance and/or quality of a manufactured piece of wood flooring (knots, grain pattern, naturally occurring color variations, etc.). Grading tolerances for both solid and engineered wood flooring are manufacturer and product specific. There are many proprietary grades from one manufacturer to another that dictate aesthetic and physical characteristic tolerances within a designated grade.

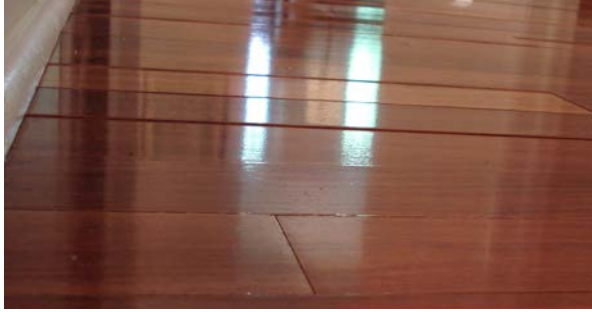
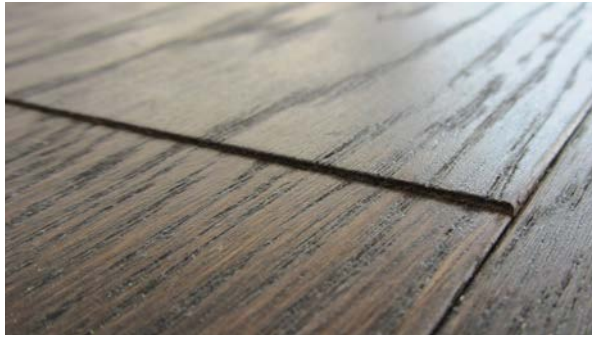
## Overwood/Underwood

**DEFINITION:** A vertical offset that exists between two adjoining installed floorboards.

- Manufacturing defect. Can be determined with destructive testing or on uninstalled wood flooring boards. Solid and engineered wood flooring manufactured tolerances outside of the applicable industry manufacturing standards (NWFA/NOFMA, HPVA, or similar).

- Deflection in subflooring.
  - Debris between boards or subfloor during installation.
  - Improper fastener schedule.
  - Improper fastener used (wrong length, gauge, type).

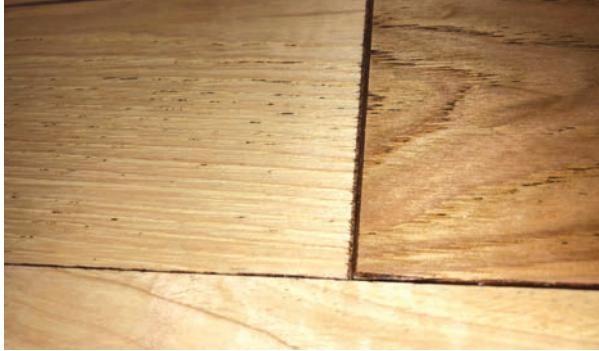
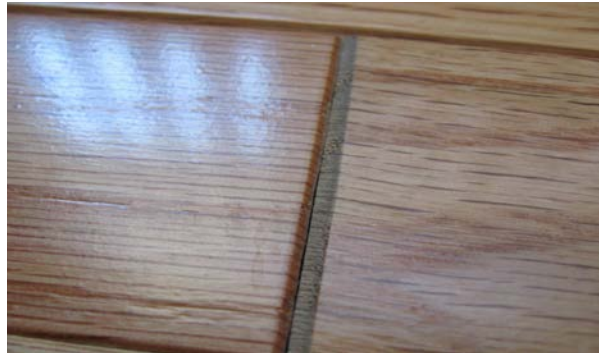
## Uneven Bevels

**DEFINITION:** Bevels within an installed or uninstalled wood floor appear inconsistent in width, depth, shape, profile, or size.

- Mis-milled flooring.
- Flooring installed from different product lines/manufacturers/runs.
- Normal and within grade for flooring installed (such as hand scraped/distressed/reclaimed).
- An existing floor with bevels that was resanded and resulted in uneven bevels.
- Installer manipulated material.

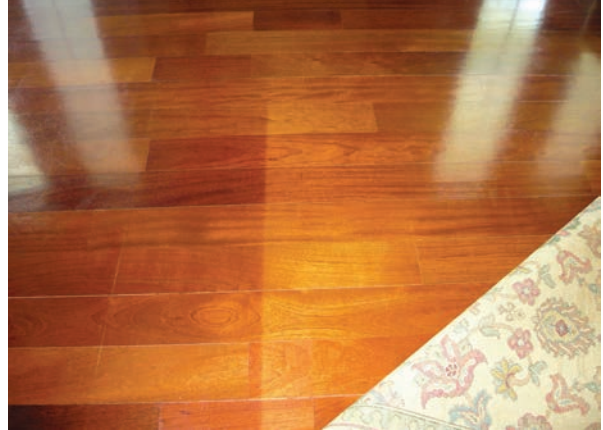
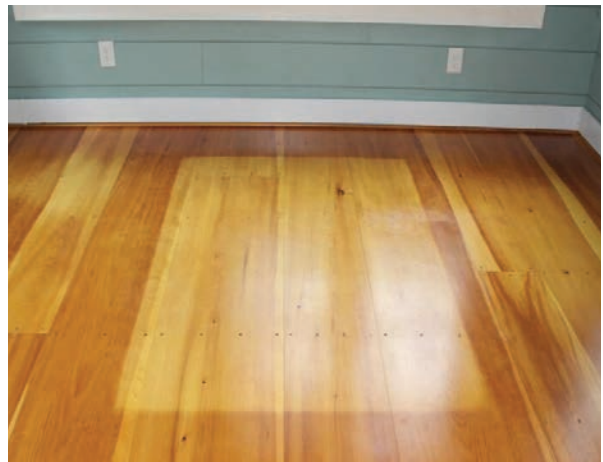
## Wood Discoloration

**DEFINITION:** The wood itself changes color over time (darkens or lightens).

- Wood changes color through oxidation and/or photochemical exposure, which is a change that cannot be prevented. This is a naturally occurring phenomenon. All woods will change color, but some more drastically than others. This is a natural change, and should be taken into account when selecting flooring from sample boards.

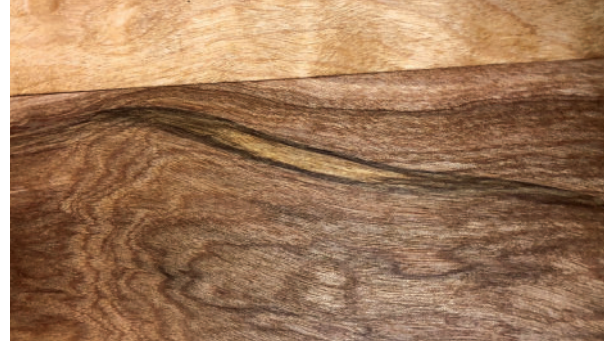
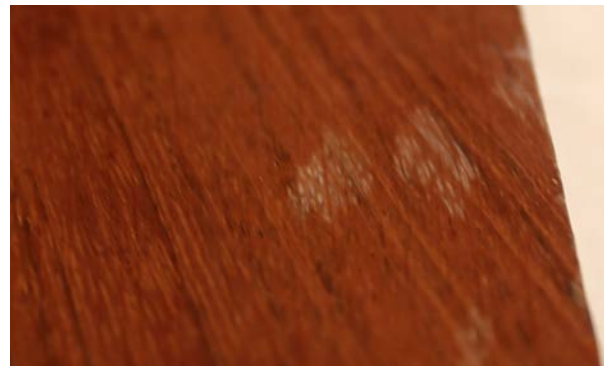
## Mineral Streaks/Deposits

**DEFINITION:** A discolored line, spot, or band in the wood that may range in color from light gray to tan, olive green, brown, purple, blue, or black. Mineral streaks/deposits are naturally occurring and they are often considered to add value and appeal to the wood.

- The source of these mineral streaks/deposits is often undetermined, and is considered a naturally occurring characteristic of living trees. These deposits may develop as the tree absorbs and deposits minerals from the surrounding soil such as limestone, sulfur, nitrogen, phosphorus, potassium, silica, gypsum, or any other mineral found in the region where the tree was grown.
- Some mineral deposits such as silica are often mistaken for chemical stains in some imported species, because of how they may appear as spots or blotches.
- Some mineral streaks may be caused by normal cell physiology occurring from wounds caused by insects, animals, weather, or logging.

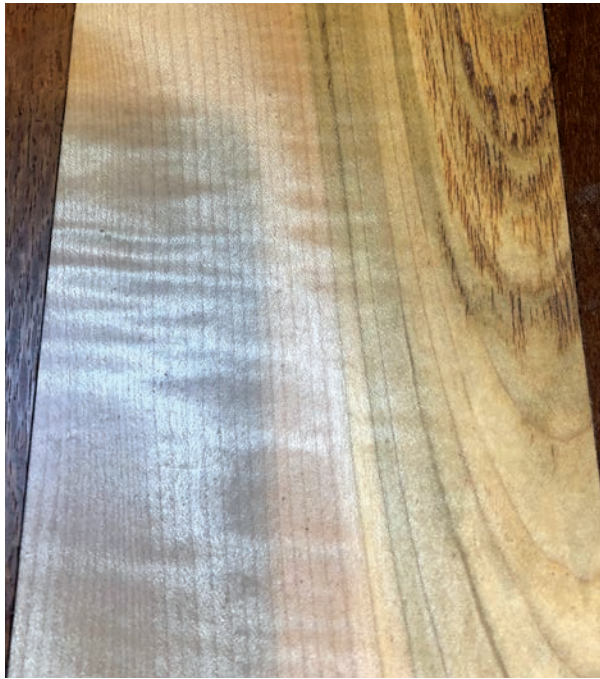
## Sap Stains (Blue-Stain or Brown-Stain)

**DEFINITION:** A discoloration in the sapwood. Sapwood itself is the active wood near the outside of the living tree. It is often lighter in color than the heartwood of the tree. Sapwood color variation is normal and acceptable in all grades, and must not be confused with sap stain.

- Sap stain is caused by the growth of certain fungi on the surface and in the interior of the wood when the moisture content and surrounding conditions are prime for this fungal growth. The wood may become prone to this fungi in standing or fallen timber, or during seasoning prior to the kiln-drying process.
- This discoloration is often known as Blue-Stain or Brown-Stain due to the color of the fungi. In kiln-dried lumber, this fungus is not living, does not cause decay, is not a mold, will not spread, is not a health concern, and will not affect the structural integrity or the strength of the wood.

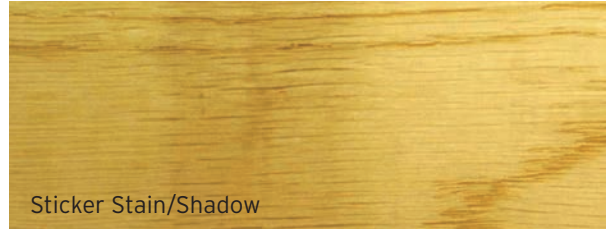
Sticker Stain/Shadow

**DEFINITION:** A discoloration on the face of a board associated with the location of the stacker sticker. Sticker stain should not be confused with machine burn, which may look similar, but will often sand out.

- Stickers are thin strips or boards used to separate the layers of lumber stacked in a pile in order to permit air circulation during seasoning. These stickers can leave a brown or blue stain that develops in seasoning lumber where it has been in direct contact with the boards.
- Sticker stain discoloration is the result of naturally occurring chemicals within the wood (drying wood and/or stickers) that occur during the drying process.
- Seldom, if ever, will there be any fungi associated with sticker stains.

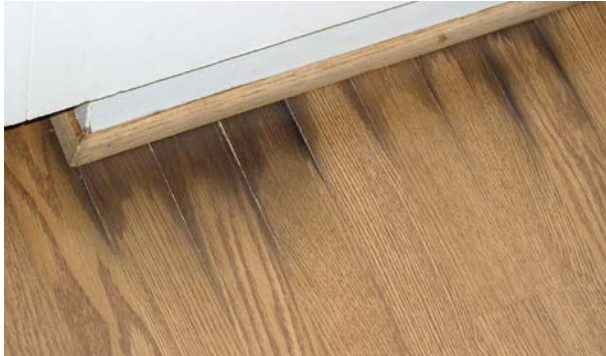
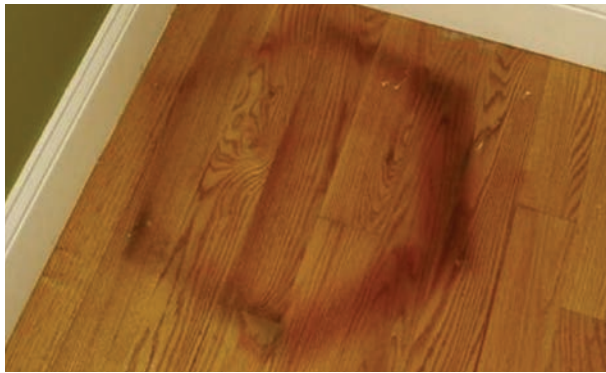
## Moisture Stains

**DEFINITION:** The wood or finish changes color with exposure to moisture.

- Moisture from below can cause dark staining, or a white haze between seams and on the surface of the wood.
- Topical moisture (incompatible maintenance products, spills, steam, etc.) can cause blushing or damage to the finish itself.

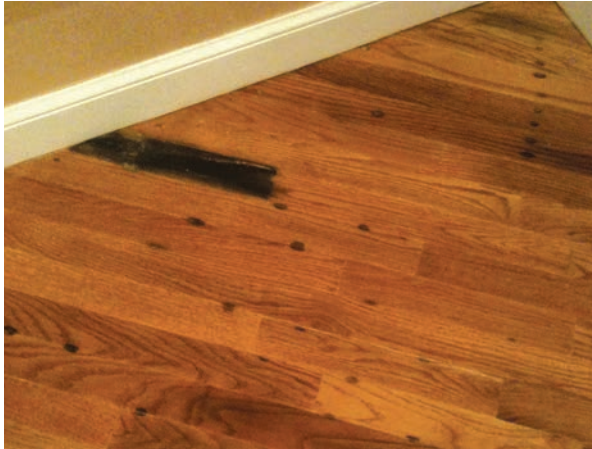
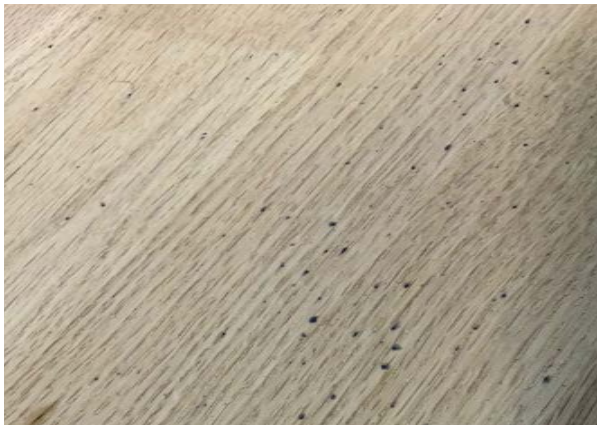
## Iron Stains

**DEFINITION:** A result of a chemical reaction between wood tannins, water, and iron.

- A chemical reaction between extractives in the wood and iron in steel products, such as nails, screws, and other fasteners and appendages.
- Floor scraper filings/shavings left on the flooring surface that reacts with water or water-based products.
- Residual from some types of abrasives left on the flooring surface that reacts with water-based products.
- In extreme moisture condition cases, substrate exposure to moisture leaching into the wood floor from below (iron fasteners or from within the slab).
- Metal containers or objects (such as paint or watering cans) in direct contact with the floor, which have been exposed to moisture.

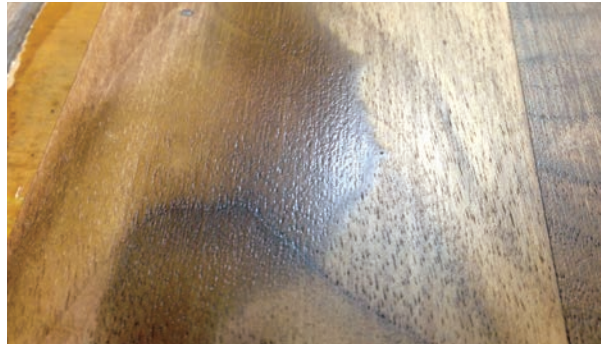
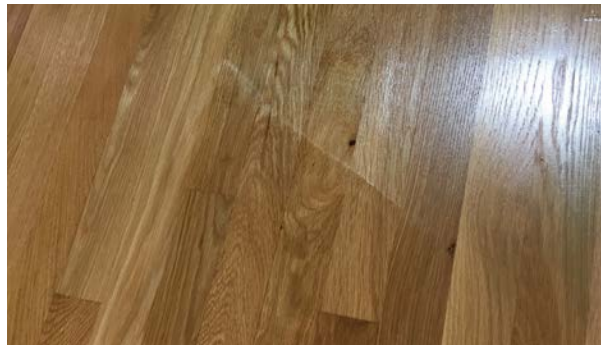
## Tannic Acid Discoloration/ Tannin-Pull

**DEFINITION:** Tannic acid includes various naturally occurring soluble astringent complex phenolic substances found in trees (and plants) as a way of protecting the tree from insects, fire, and bacteria. High levels of tannic acid present in woods like oak, walnut, and mahogany can produce a dark discoloration when coming in contact with some products used in the finishing and maintenance of wood floors.

- Tannic acid is water-soluble and may discolor when it comes in contact with iron and water, which usually appears as a bluish/grey discoloration on the wood.
- Tannic acid discolors when it comes in contact with materials that are alkaline by nature, such as ammonia. Most water-based finishes are manufactured with pH adjusters (such as ammonia), which can cause a green/brown discoloration on the surface of the wood, and may also partially bleed into the finish.
- Unevenly applied water-based coatings, especially heavy spots, puddles or streaks.
- Not using or improper application of a tannin-blocking sealer.
- Application of a top-coat over a sealer that has not adequately dried.

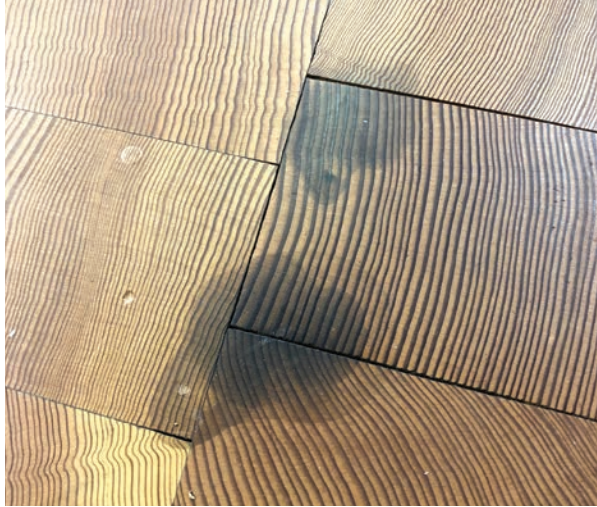
## Chemical Stains

**DEFINITION:** Irregular shaped spots or discolorations on areas of the finished floor caused by reactive chemicals and/or air pollution.

- Household chemical spills or cleaning products (nail polish remover, ammonia, chlorine, mustard, iodine, oil, milk, ethyl alcohol, acetic acid, etc.) reaction with wood floor finishes.

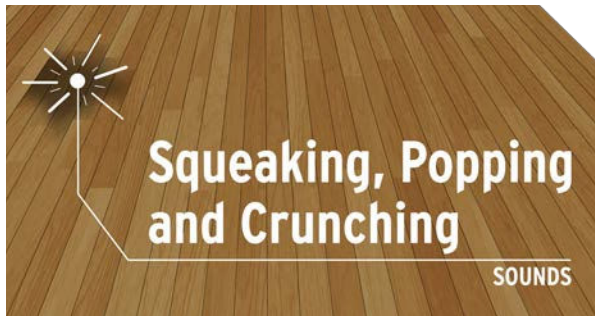
## Squeaking/Popping/ Crunching Sounds

**DEFINITION:** Audible squeaking, popping, or crunching noises in an installed wood floor or within the floor system. Squeaks are not a direct concern with the installed wood floor as long as movement accompanying the audible squeak does not affect the performance of the installation. An occasional squeak within any properly installed wood floor system is not abnormal.

- Old age of the floor and/or structure.
- Wood flooring installed while not in equilibrium with the end-use environment. A change in temperature/humidity that causes the wood floor to change moisture content, and ultimately change dimension of the flooring and tongue and groove match, can result in audible noises, squeaks, pops, or crunching sounds.

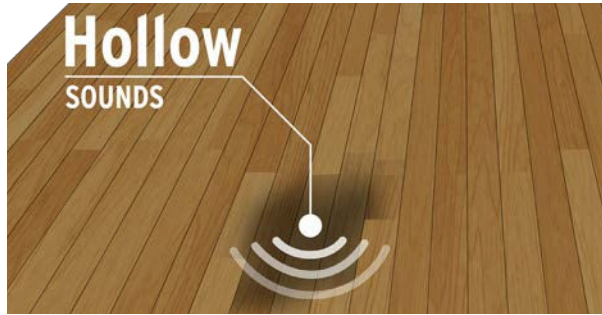
## Hollow Sounds

**DEFINITION:** An audible hollow sound in the installed wood flooring. When no deflection is present, this may be considered normal with many installation methods provided that the installation followed proper installation procedures. Hollow sounds are not a direct concern with the performance of an installed wood floor as long as there is not movement accompanying the audible hollow sound.

- Nail-down wood floors:
  - A void in the flooring itself (wormholes, shake, bark pockets, engineered flooring core voids, etc.).
  - Slight imperfections or voids in the subfloor.

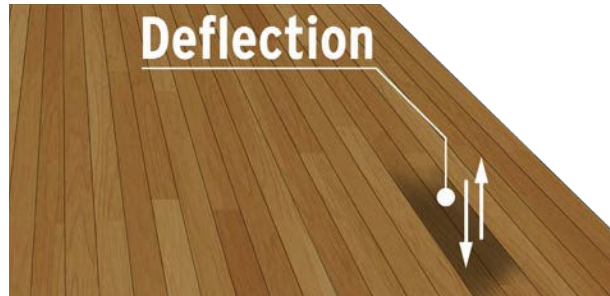
## Deflection

**DEFINITION:** Isolated areas in an installed floor system that exhibit vertical (up and down) movement when pressure is applied.

- A void in the flooring itself (wormholes, shake, bark pockets, engineered flooring core voids, etc.) resulting in vertical movement.
- Mis-milled flooring/loose tongue and groove engagement (outside of manufacturing tolerances at the time material was manufactured).

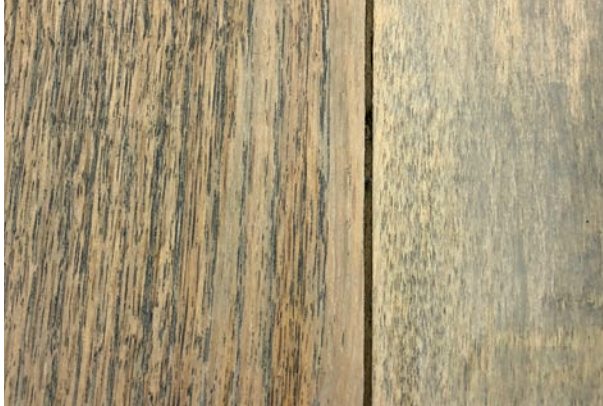
## Seasonal/Normal Gaps

**DEFINITION:** Gaps that appear between individual boards, opening and closing with seasonal humidity changes. Wider boards can experience wider gaps. Gap size is directly related and proportional to the board width.

- Most normal gaps are caused by seasonal fluctuations in relative humidity. The floor expands with high humidity and contracts with periods of low humidity. This type of expansion and contraction is considered to be normal and expected with wood floors when exposed to seasonal variations.
- When wood flooring is installed during dry seasons where relative humidity is not maintained, it is normal to leave internal expansion spaces/gaps (washer rows) within the floor to accommodate for seasonal humidity changes.

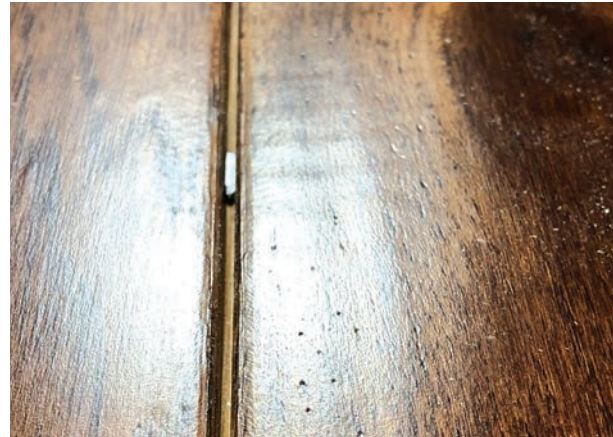
## Abnormal Gaps

**DEFINITION:** Gaps between abutting wood floor boards in the installed floor that were not intentionally placed and remain with seasonal fluctuations in moisture and humidity.

- Flooring not installed tightly together.
- Debris between the boards during installation.
- Solid wood flooring installed at higher moisture content than what the normal, in-service conditions can support.

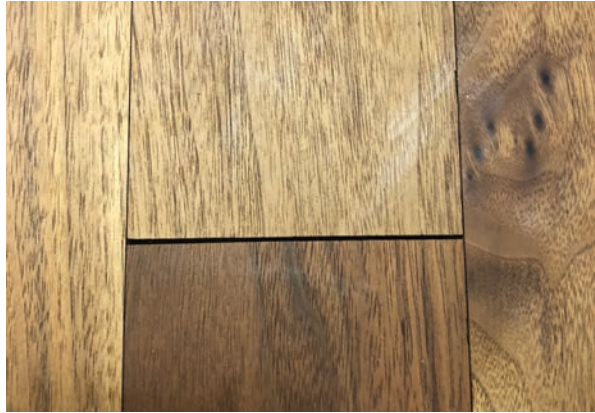
## End-Gaps

**DEFINITION:** A separation that occurs on the ends of two abutting wood floor boards.

- Loss/gain of moisture in engineered flooring.
  - Due to the construction of engineered flooring, each layer shrinks and swells in different directions and at different rates than the adjoining layers. It is common for it to shrink/swell in its length when exposed to changes in moisture content.

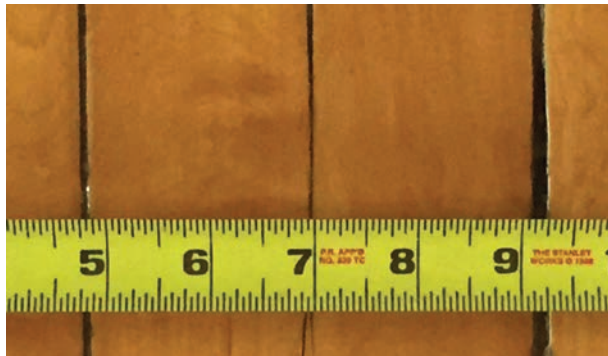
## Compression-Set

**DEFINITION:** A generally uniform appearance of gaps between wood floor boards that directly coincides with the narrowing/crushing of individual board edges as a result of permanent cellular damage. The appearance of a compression-set floor may be similar to gaps from other causes, such as flooring that was milled and installed with high moisture content. When they are at the same moisture content at which they were milled, compression-set boards will be narrower than the milled width and may exhibit slightly raised edges along the board edges.

- Exposure to substantial moisture causing excessive expansion, and resulting in damage to board edges, followed by lower moisture levels and subsequent contraction of the affected boards.
- Once the wood fibers have been damaged, they may be unable to regain their original dimensions.
- The compression can become exaggerated by debris becoming embedded in the gaps between boards.
- Filling seasonal gaps during the dry season can cause compression-set when the floor expands again during the more-humid months.

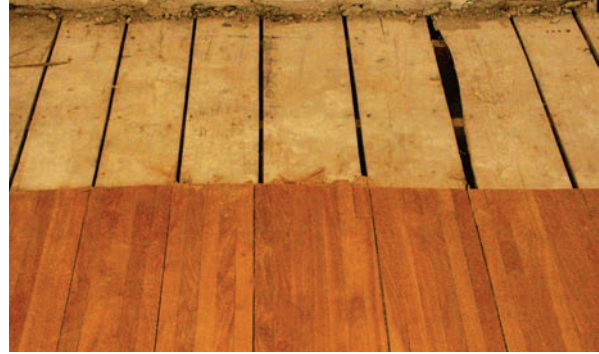
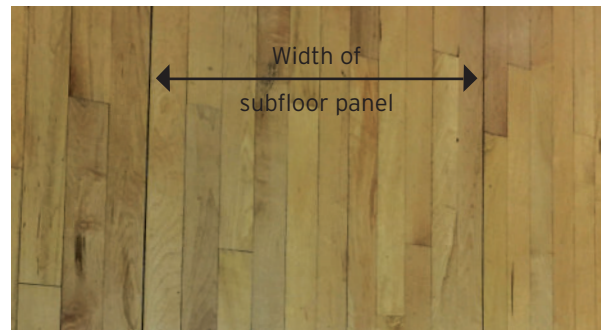
## Panelization

**DEFINITION:** A generally uniform appearance of gaps or peaks in the surfaces of the wood floor that directly coincide with movement in the subfloor material beneath it.

- Moisture-related subfloor issues.
- Acclimation related issues:
  - Moisture content of the wood floor and subfloor are not aligned at the time of installation.

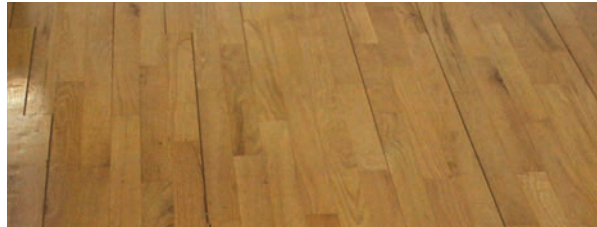
## Sidebonding

**DEFINITION:** A condition where localized gaps develop between flooring boards while adjacent groupings of boards remain tightly bonded together with no apparent separations. These gaps will sometimes exhibit wood fractures along the gap as a result of the finish bond tearing away small pieces of wood from the adjoining plank. Sidebonding should not be confused with panelization. (See Panelization.)

- When installed wood flooring shrinks due to a loss of moisture, and the edges of individual boards have become adhered to one another due to:
  - Finish (most common with water-based finishes) that has seeped between the boards, drying and forming a permanent bond adjoining/gluing boards together.
  - Glue that has been used on the tongue and groove during installation, adhering the planks together.
- Not using a sealer, either water-based or oil-based (sealer, stain, or polyurethane), as recommended by the finish manufacturer, prior to applying the rest of the finish system.
- With recoat scenarios in which cracks are present or unfilled, finish will fill the voids and potentially result in sidebonding.

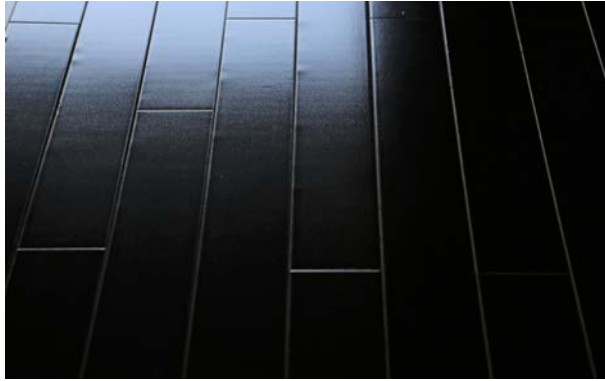
## Telegraphing Fastener/Dimpling

**DEFINITION:** Dimples or bumps along the nailing surface of the finished flooring, directly related to fastener location and/or installation method.

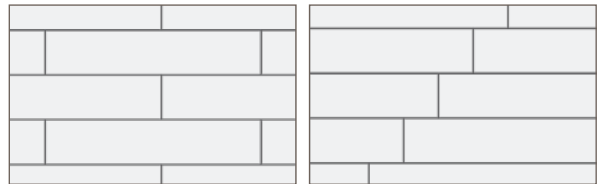
With solid or engineered wood flooring installed over concrete or a wood panel subfloor and joist systems that meet or exceed NWFA minimum requirements, properly staggered end joints are an appearance/aesthetic consideration.

With 3/4" and greater strip or plank wood flooring installed over bare joists, solid board subfloors (1"x6"), "perpendicular car decking," sleepers/screeds, other non-continuous subfloor systems, or panel-type subfloors that do not meet NWFA minimum requirements, the layout of the entire floor, and end joint placement, are not only an appearance/aesthetic consideration, but also add a structural element to the finished installation. Stair-stepped and clustered end joints may reduce the ability of the flooring system to withstand the additional stresses created in these circumstances.

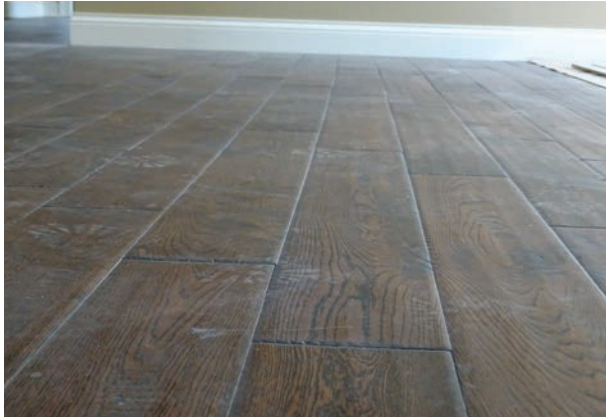
## Crooked Installation Discrepancies

**DEFINITION:** An installed wood floor appearing bowed or out-of-square within the room in which it is installed. No wood floor installation is perfectly straight, parallel, or perpendicular to walls or fixtures. When the straightness of the installed floor takes away from the overall appearance of the floor within the structure, an aesthetic remedy may be necessary. The performance and structural integrity of the wood floor is not normally affected with any floor that has been installed out-of-square or out-of-a-straight-line.

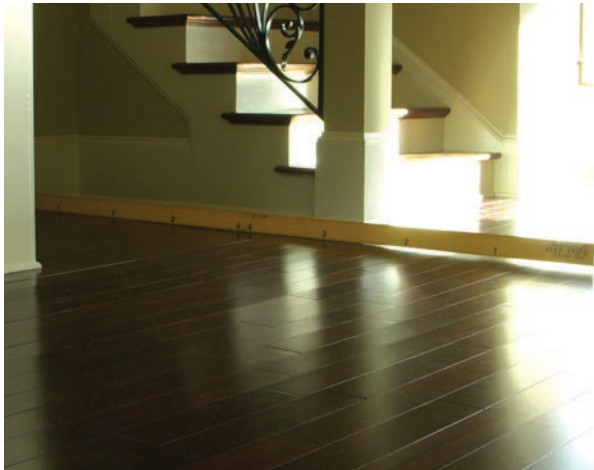
**DEFINITION:** The installed wood floor system appears to be uneven, wavy, or out of flat. Wood floors may be installed over out-of-level subfloors, but should fall within NWFA floor flatness tolerances. Subfloor flatness cannot be quantifiably measured when a floor covering is in place over it (without potentially extensive destructive testing), however, may give a good indication of what is happening below.

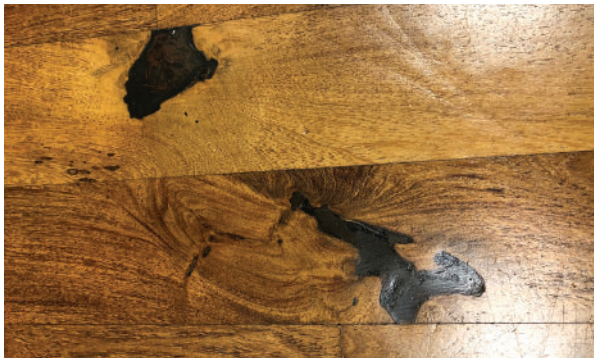
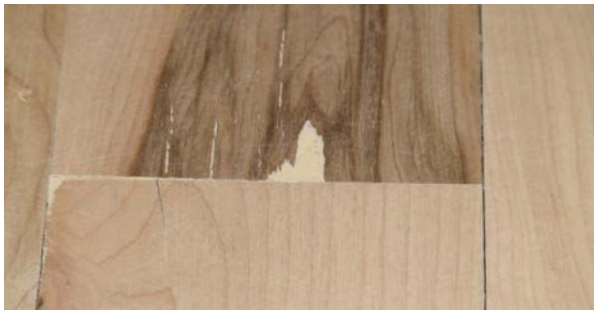
## Filler Color Variation

**DEFINITION:** The wood filler from one area of the floor is different from the overall color tone of the floor. No two trees from the same species are identical, no two boards from the same tree are identical, and color and grain patterns can vary even within one individual plank of wood. Wood filler will never perfectly match, nor is it designed to match every board within a wood floor.

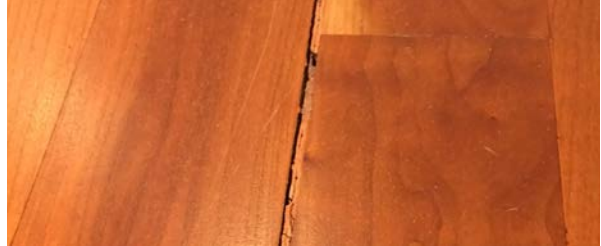
## Popped Filler

**DEFINITION:** Wood floor filler that has become loose or no longer fills the void it was once in.

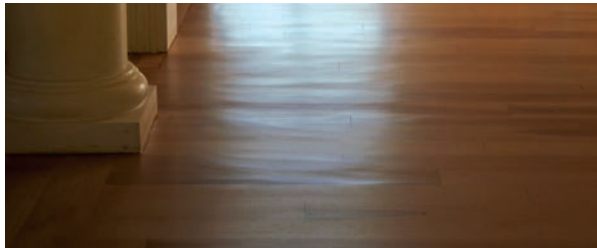
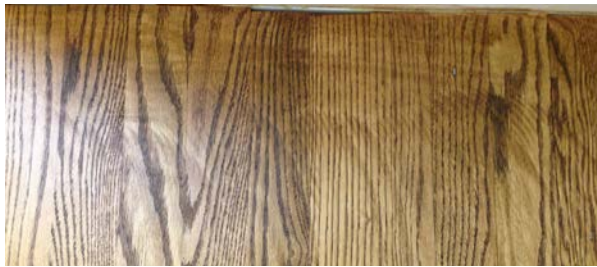
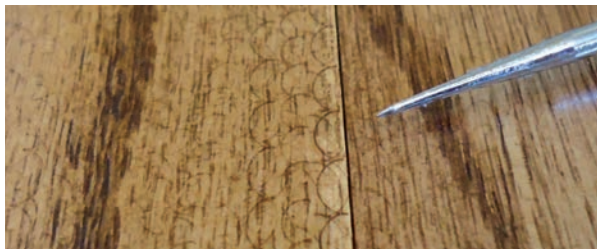
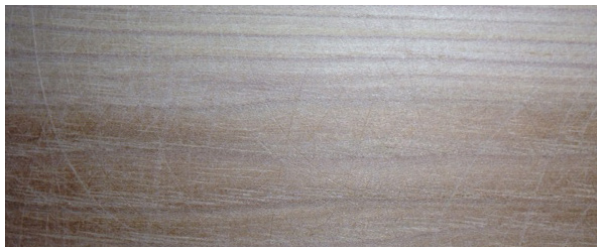
## Sanding Marks

**DEFINITION:** Sanding imperfections seen as drum marks, side cuts, sanding scratches, or swirl marks. Sanding marks should be viewed from a standing position on the floor being assessed, in ambient lighting conditions. Glare from a direct light source must not be used during evaluation. Inspection may take place from floor level and/or with assistance of magnification in order to determine causes of irregularities, but not to determine acceptability.

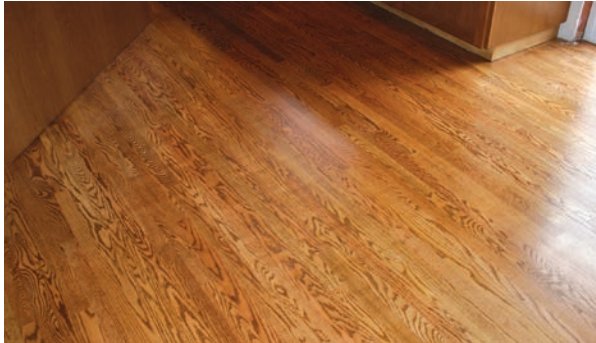
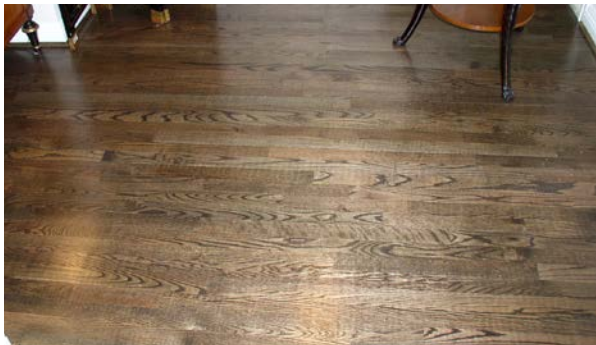
## Chatter

**DEFINITION:** Slight unintentional indentations causing a ripple-like wave effects or “bars” that run perpendicular to the wood’s grain direction on the surface of a wood floor which can become visibly pronounced in direct lighting. The width of these “bars” can range from just a few millimeters to nearly an inch from peak to peak, and can occur in limited regions or can span the entire floor.
