# PROBLEMS, CAUSES, AND CURES

Technical Publication No. C200 • Revised © 2018 | 3rd Edition

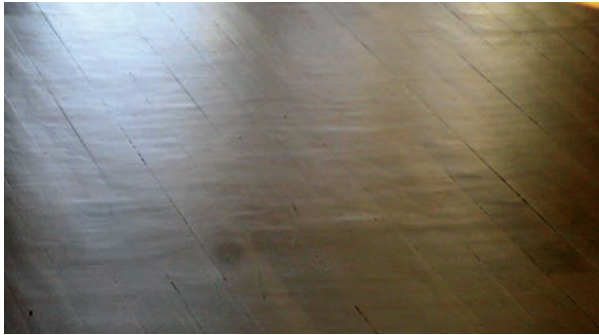
## Wave

**DEFINITION:** Indentations, usually repeating undulations, visible on a site-sanded wood floor surface, most often visible after a finish has been applied. The width of these irregularities typically range from one inch to three inches or more, and can occur in limited regions or can span the entire floor. Wave can sometimes be in conjunction with, or confused with, dishout.

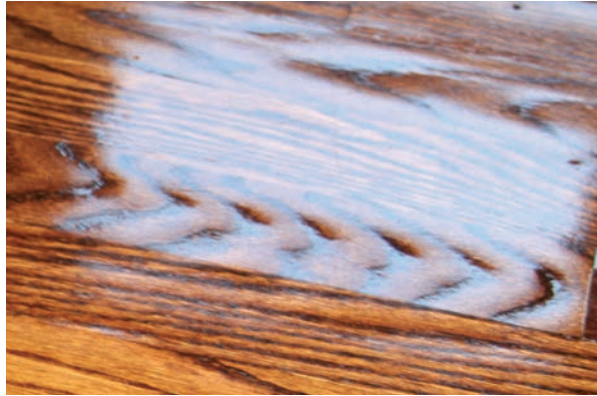
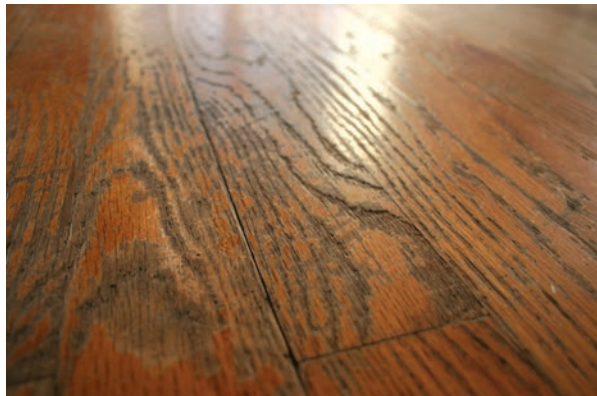
## Dishout/Shellout

**DEFINITION:** Undulations in the surface of individual boards or within the wood floor, resulting from softer areas having been worn, hollowed, or sanded to a lower level than harder adjacent areas.

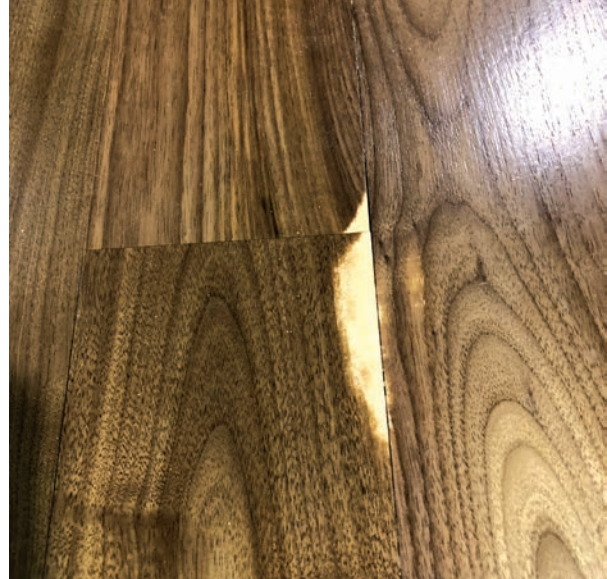
## Veneer Sand-Through

**DEFINITION:** The top/wear layer veneer (lamina) of engineered flooring has been completely sanded through to the core layer.

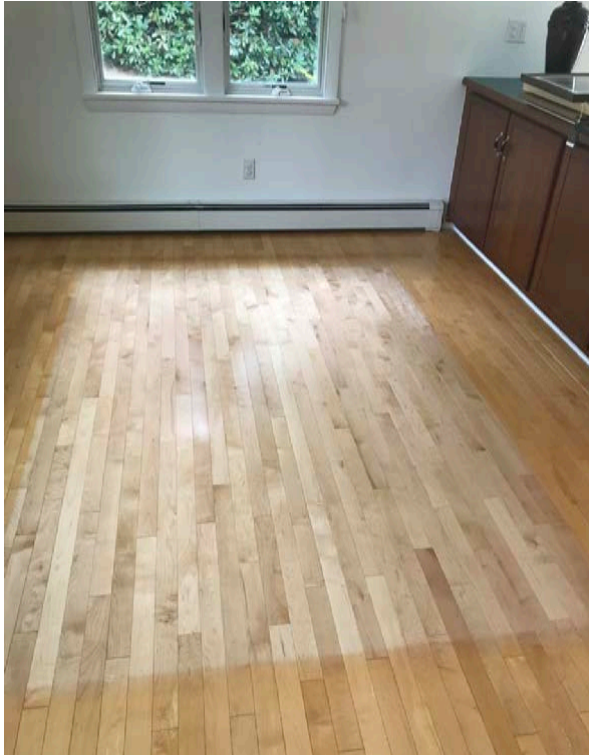
## Finish/Colorant Discoloration

**DEFINITION:** The finish or colorant systems changes color.

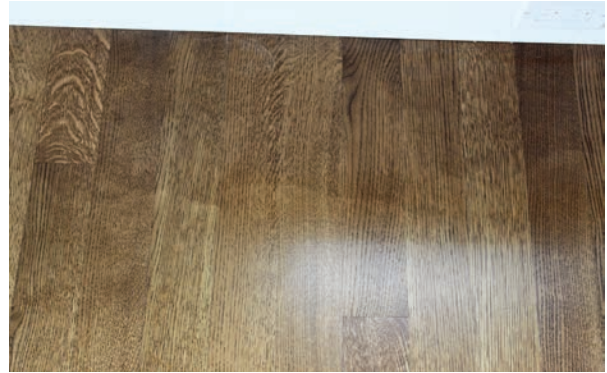
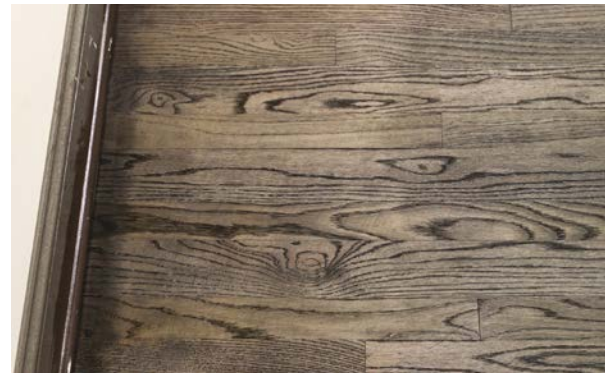
## Picture Framing/Halo

**DEFINITION:** The edges of the room appear to be a slightly different color than the rest of the room.

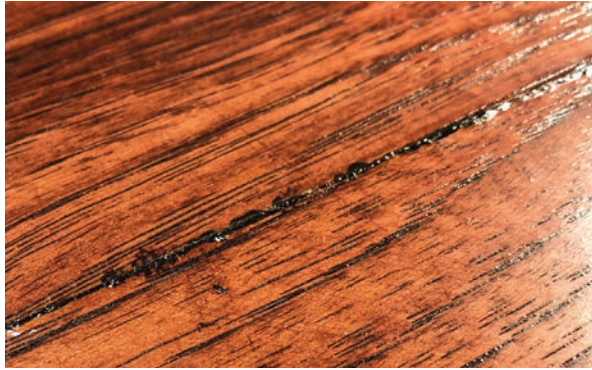
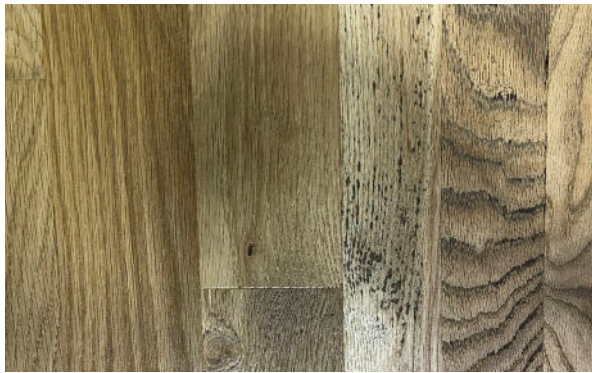
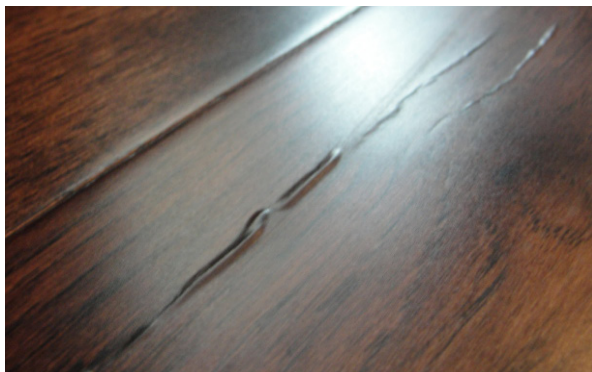
## Stain Bleed Back

**DEFINITION:** A staining phenomenon occurring after the initial application of the stain, where the stain seeps back to the surface of the wood. This may happen at board seams, with open-grain species, tight grain, knots, or burls.

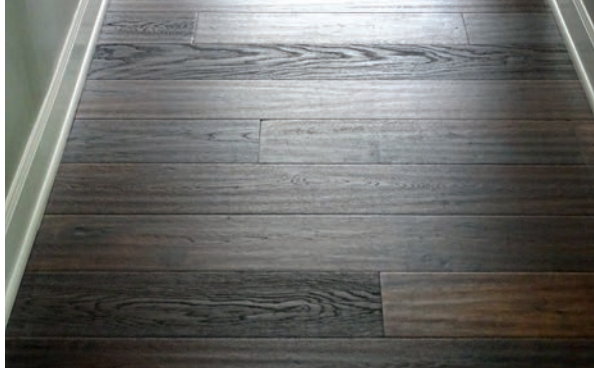
## Finish Film-Thickness Discrepancy

**DEFINITION:** A discrepancy in the depth of the film of finish applied to a wood floor. Mil/film thickness of finish can be evaluated, but should not determine acceptability.

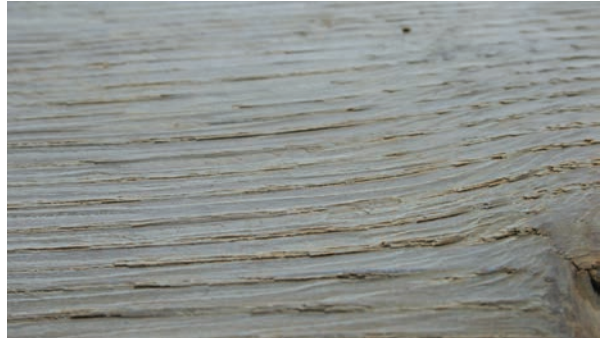
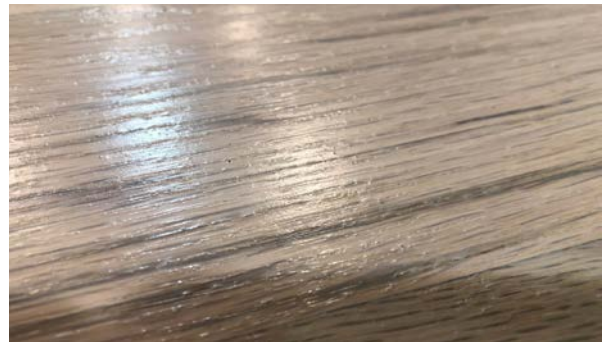
## Roughness/Grain-Raise

**DEFINITION:** The surface of the wood floor feels rough to the touch.

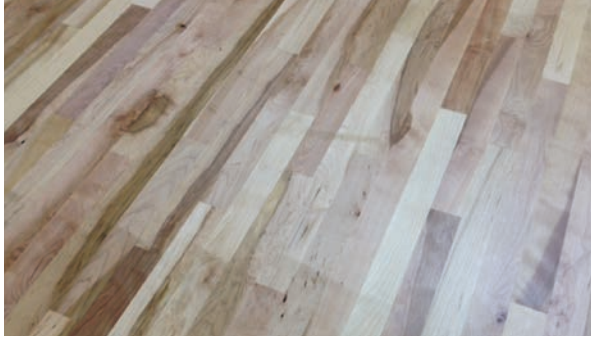
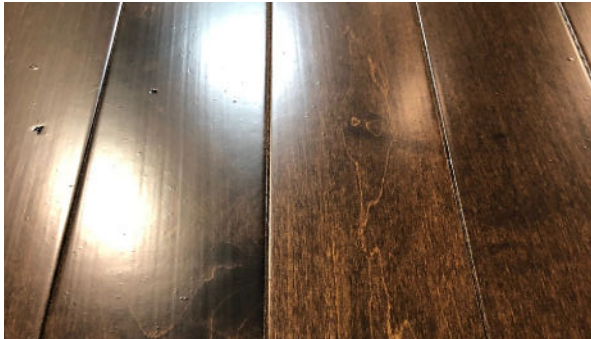
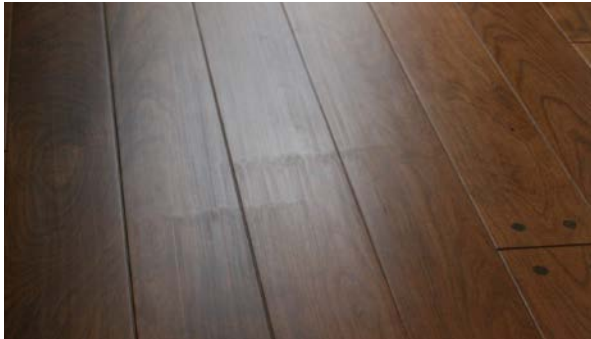
## Applicator/Finish Streaks

**DEFINITION:** Visible ridges, lines, or marks left on the wood floor, representing the application tool used from any stage of the finishing process.

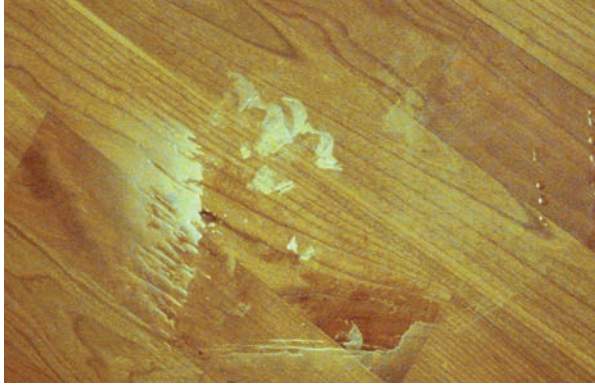
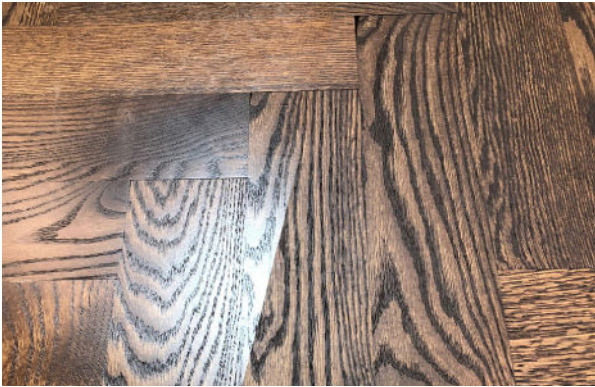
## Holidays/Skips

**DEFINITION:** An exposed area of uncoated wood or the undercoating, when the intention was to coat the entire area.

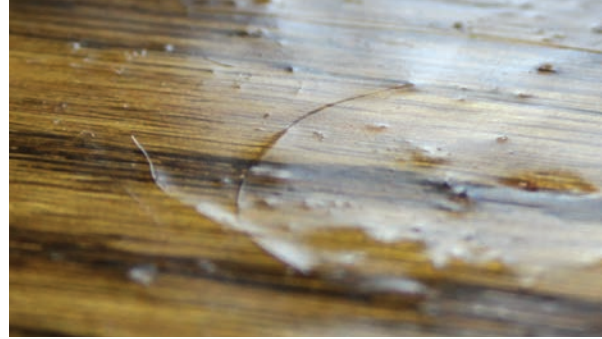
## Debris in Finish

**DEFINITION:** A raised bump in the film of finish often consisting of dust, hair, applicator fibers, foreign contaminants, solid finish particles, or other artifacts. Due to the nature of most coating environments, minimal amounts of debris within reason can be expected in any coat of finish.

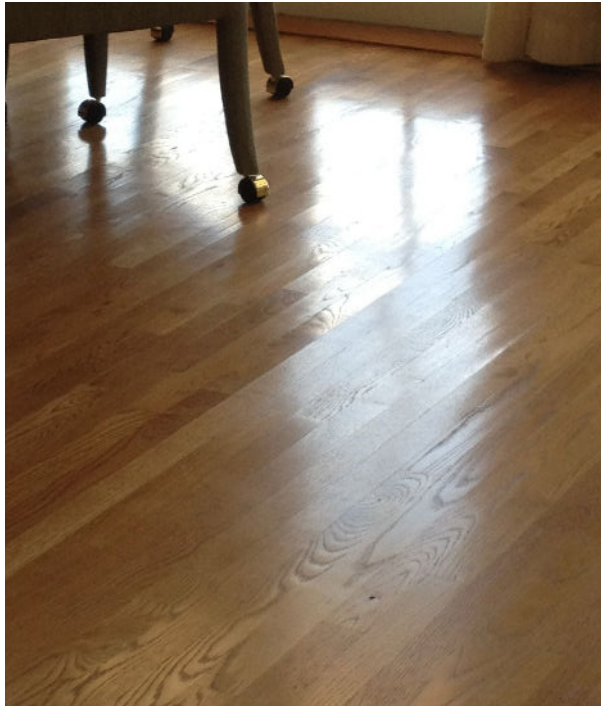
## Uneven Sheen/Gloss Levels

**DEFINITION:** The sheen or gloss level of the final coat of finish varies from one area of the floor to another. As film-forming finish products decrease in gloss, they increase in amounts of matting agents. Lower sheen products have the most matting agent, and thus, can more-easily manifest uneven sheen levels. Sheen/gloss levels should not be assessed until all final coats have been applied and are fully cured.

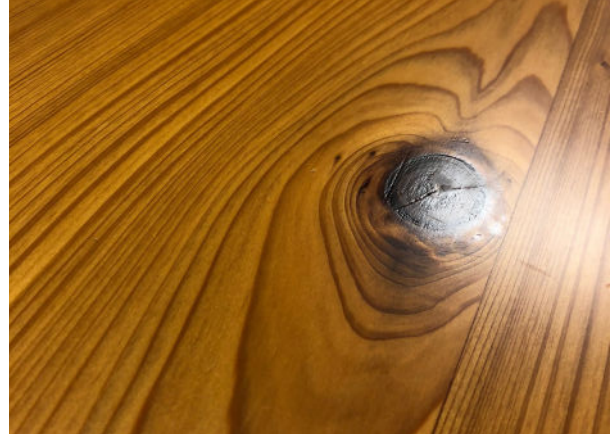
## Sticky Board Syndrome

**DEFINITION:** Wood floor finishes that do not dry, adhere, cure properly, or appear the same on specific areas of a board or individual boards.

- Species with high concentrations of tannic acid, a pH imbalance, natural oils, or sap from a variety of species may adversely affect the finish's ability to properly dry and cure.
- Knots on species such as pine or Australian cypress affecting the ability of the finish to properly dry and cure.
- Contamination within the wood or between boards affecting the ability of the finish to properly dry and cure.
- Insufficiently cured UV finishes (factory-finished or site-finished).

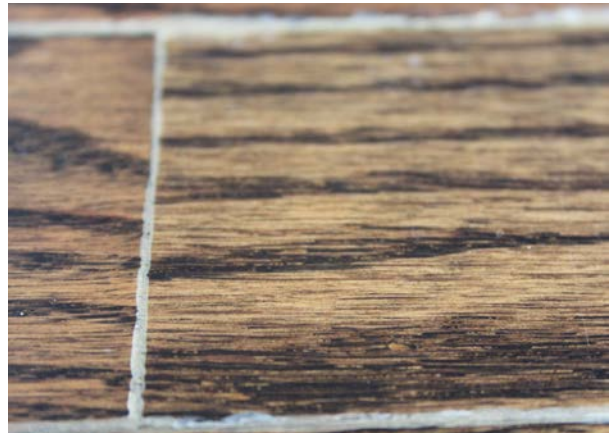
## White Lines

**DEFINITION:** White lines appear between board edges of site-applied film-finishes.

- The optical result of finish or sealer that stretches, rather than breaks, along board edges or seams, with seasonal humidity and temperature fluctuations.
- Applying a more-elastic finish on top of a less-elastic one.
- Solvent-trap:
  - In areas between boards, cracks, seams, butt-joints, or filled knot holes where oil-based stain has penetrated and often pooled, the solvents take longer to evaporate, translating to longer dry times. When the floor gets coated, these solvents become trapped within the finish film at these sites.
  - Applying finish over a sealer coat, finish, or stain that hasn't dried enough to be recoated yet, causing the solvents to become trapped within the coatings. This is commonly seen between gaps in the floor, resulting in cloudy lines between boards. This haze may be temporary or it may persist.

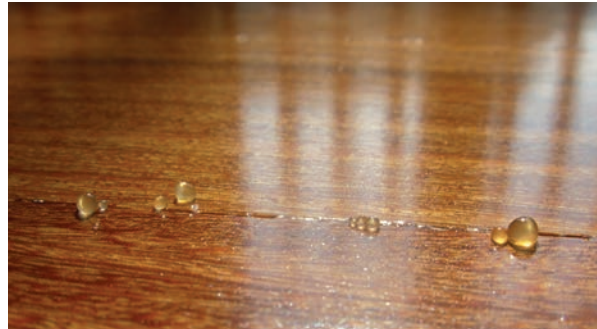
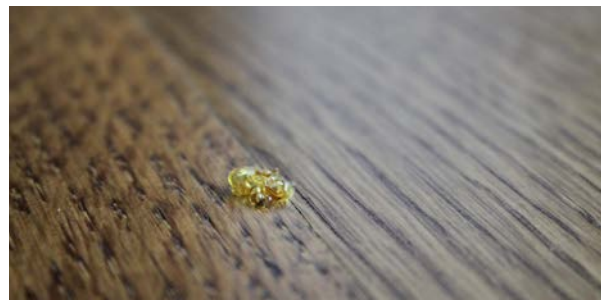
**Poly Beads**

**DEFINITION:** Small round balls that appear as beads, or “BBs” of finish, that form along the joints of the individual boards. They can be soft and sticky when first formed, and will become hard if left undisturbed. When these wet beads are stepped on, they can become unsightly smears along board edges.

- During finish application, where the finish collects in voids, such as gaps between boards, it cures at a much slower rate. Later, when the moisture content of the flooring increases (higher humidity levels), the uncured finish can squeeze out from between the boards appearing as small BBs. This is most common with oil-based urethane finishes, higher solids/more-viscous finishes, and conversion varnishes.

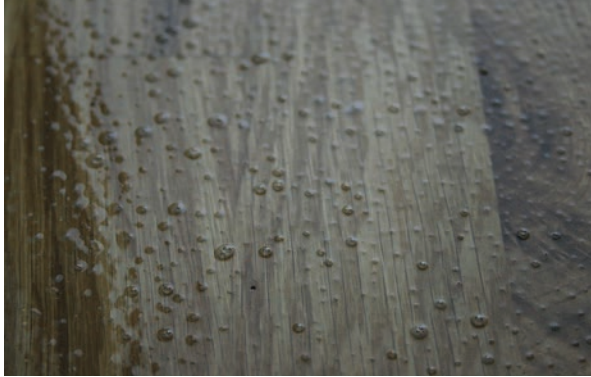
## Bubbles

**DEFINITION:** Raised bumps, or air-filled bubbles visible in the film of the finish. These include both full bubbles and bubbles that have popped.

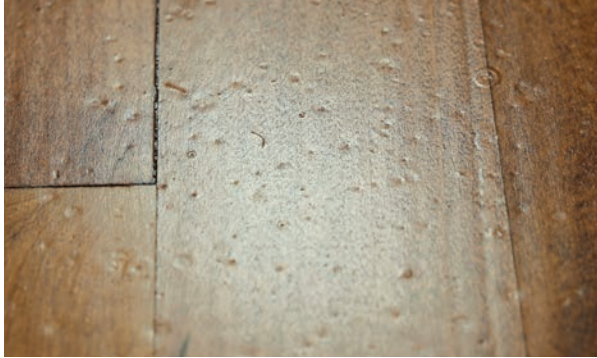
## Pin Holes

**DEFINITION:** A visible finish imperfection where the surface of the finish film recedes from a very small area or areas of the surface.

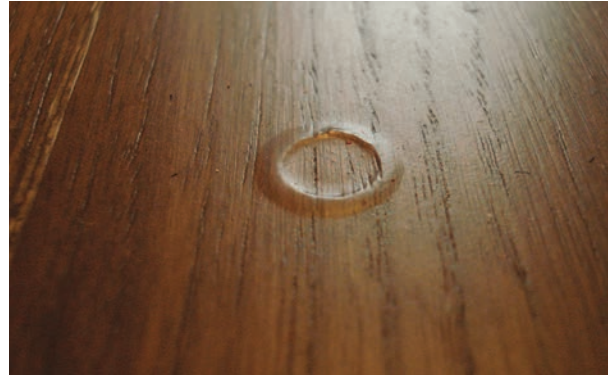
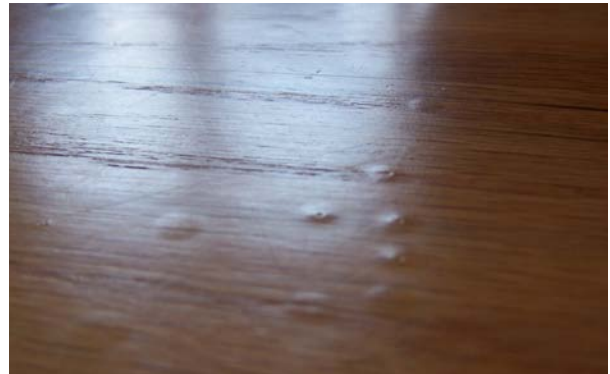
## Craters/Fisheyes

**DEFINITION:** A visible finish imperfection that manifests by the crawling of wet finish film into a single area or pattern resembling small dimples or bowl-shaped depressions, sometimes accompanied by a particle in the center.

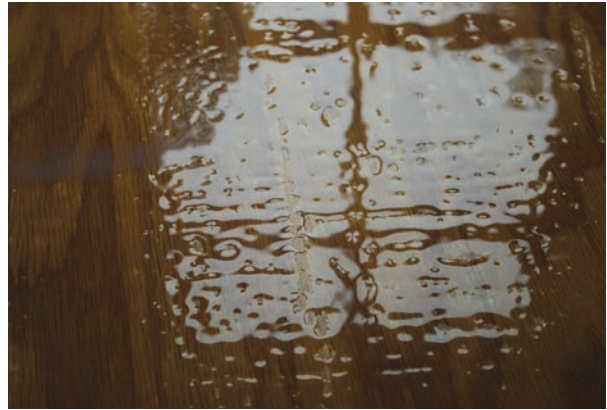
## Crawling

**DEFINITION:** A visible finish imperfection where the finish film is repelled from areas of the surface, leaving the appearance of thin or uncoated affected areas. May be very long and oval shaped, and may vary in size.

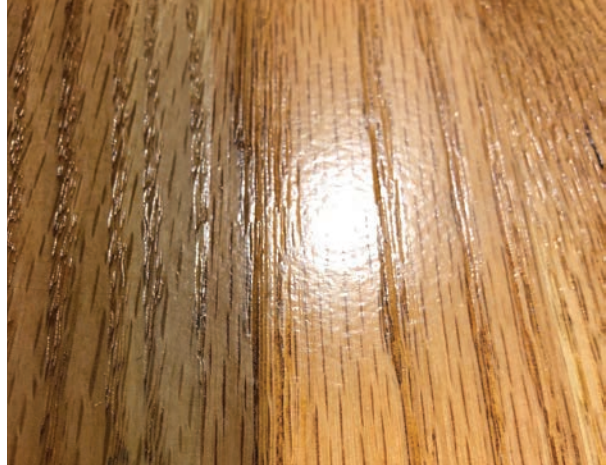
## Orange Peel

**DEFINITION:** A visible finish imperfection where the surface of the dry finish film exhibits a flaw that resembles the texture of an orange peel.

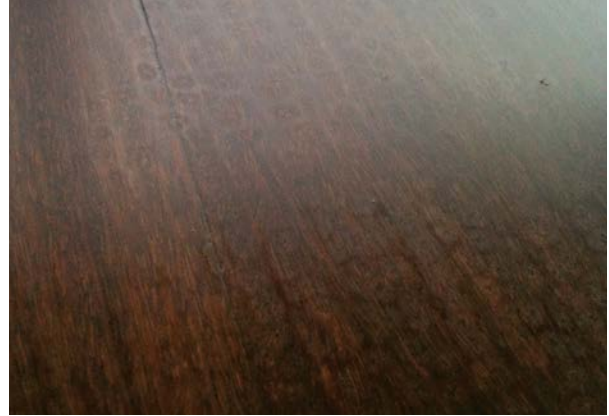
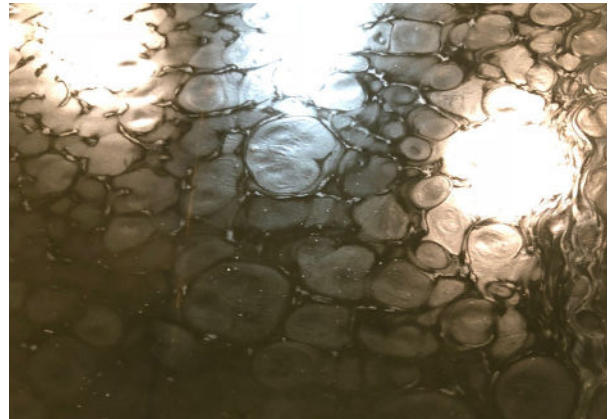
## Benard Cells

**DEFINITION:** A visible finish imperfection resembling a pattern in the smooth finish film that resembles a clustering of "cells." They typically appear as less-glossy, often round, curvy, or geometrical (hexagonal, pentagonal) in shape, and may range in size from very small, up to 1". Benard cells are more common with lower sheen or pigmented finishes.

- As solvents evaporate from the drying film, convection currents, or "eddies" are caused, where less-volatile coating components like pigments or matting agents may concentrate in patterns in the dried film.
- Normally caused by a rapid escape of solvents from the applied finish (in high temperature and low RH environments).
- Solvent additives or dry-time-extending retarders added to the finish in an improper amount or outside of the finish manufacturer recommendations.
- Allowing finish to "sit" too long after mixing, before application.

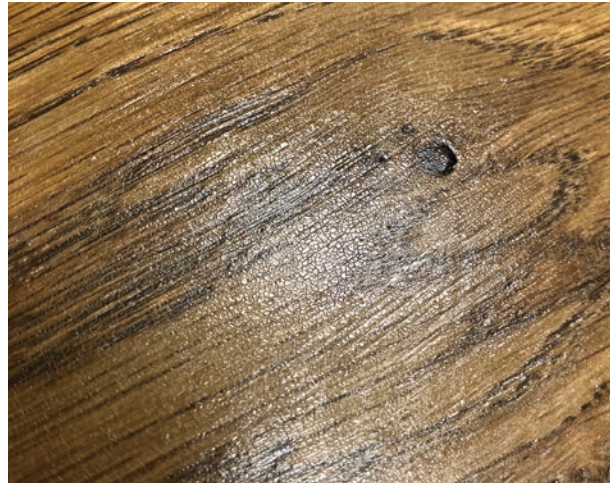
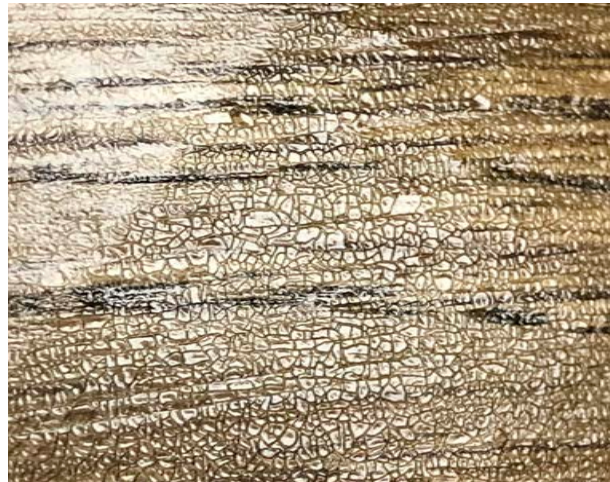
**Crazing/Alligatoring**

**DEFINITION:** A visible finish imperfection that appears as a network of very small, fine cracks or fissures in the surface of the finish film, which sometimes resembles the skin of an alligator or crocodile.

- A previous condition left in a previous coat that was not effectively removed prior to subsequent coats, telegraphing through the top-coat.
- The moisture content of the wood floor was too high at the time the coating was applied.
- Internal stresses in the top coat caused during the drying process where the top of the finish dries too quickly, causing the surface to dry and shrink faster than the full depth of the finish.
- Expired finish or catalyst/hardener.
- A water-based sealer or finish issue, wherein the film does not coalesce properly (usually due to insufficient solvent or solvent efficiency). This may be from manufacturing, or due to using product that has been expired, stored, exposed, or used at temperatures or humidity levels outside of manufacturer recommendations.

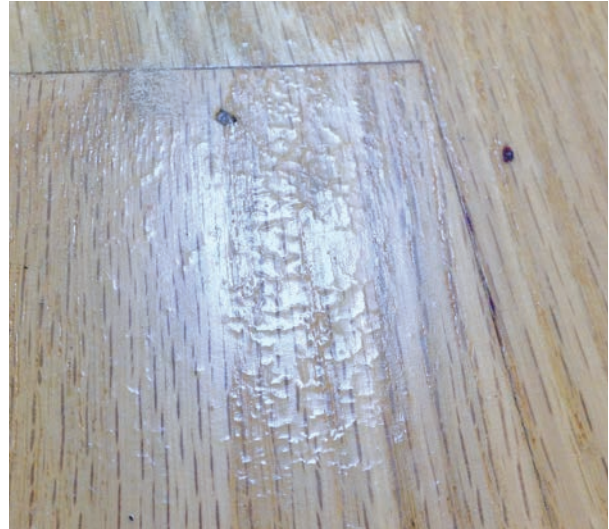
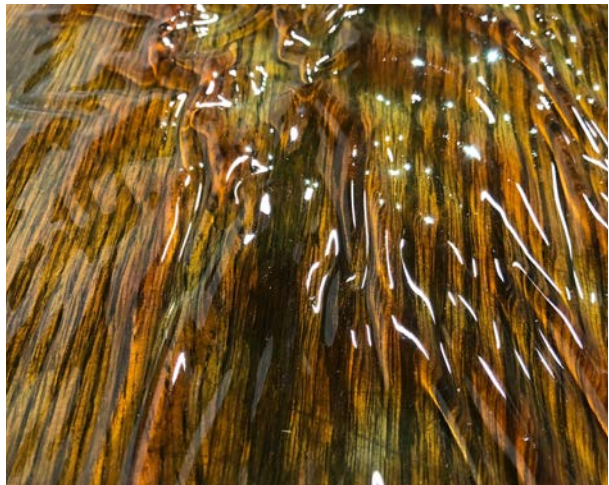
## Wrinkling

**DEFINITION:** A visible film-finish imperfection that appears as the skin of a dried prune. Wrinkling may happen with all types of film-finish, but is most common with oil-based urethanes.

- Wrinkling is a phenomenon that happens during the drying/curing process, caused by the top of a film drying before the bottom. As it dries, it contracts. Since the bottom is still liquid, it cannot prevent the contraction, resulting in wrinkling.
- Hot, dry air during the drying of the finish.
- A substrate that is too cold, accompanied with warmer air or air movement during finish application and drying.
- A finish coat applied too heavy, outside of manufacturer recommended coverage rates.
- Puddles or pools left in the finish coat often coincide with wrinkling of the finish.

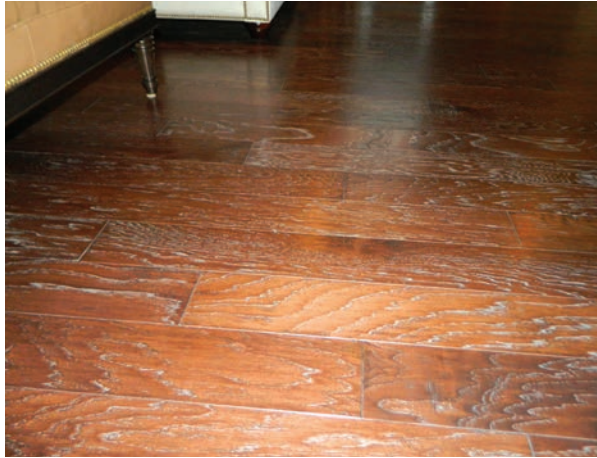
## Open-Grain Contamination

**DEFINITION:** An accumulation of contaminants in open voids or characters, such as in textured wood, the soft grain/springwood, open knots, splits/checks, etc., on the surface of the installed floor.

- Any time drywall work has been scheduled post wood floor installation, the wood floor is susceptible to becoming exposed to drywall dust. Subsequent wetting/damp mopping of the surface will turn the drywall dust into a paste, which can be extremely difficult to remove from the exposed voids or characteristics of the flooring.
- Silt, salt residue, or other fine dust particles becoming embedded in the exposed voids or characteristics of the unprotected flooring.
- Paint, flooring adhesive, or other contaminants that have been spilled and subsequently cleaned from the surface, but remains in the exposed voids or characteristics of the flooring.

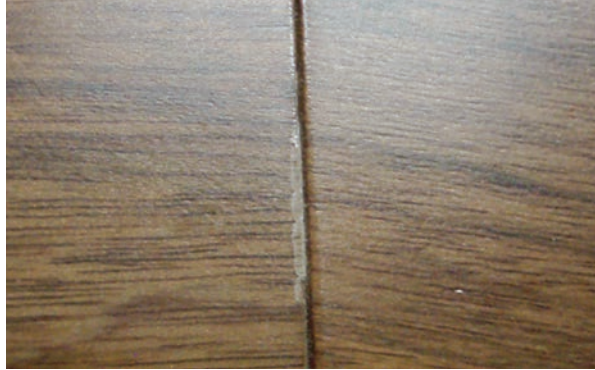
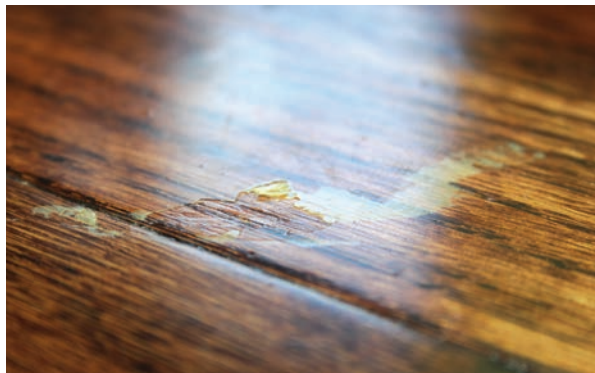
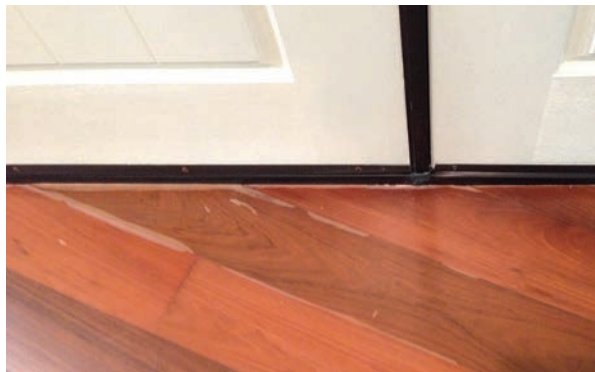
**DEFINITION:** The loss of film-finish adhesion to the flooring surface or between coating layers.

**Chipping/Flaking Finish** - The condition that occurs when a dried film of finish separates from the previously applied finish in the form of chips or flakes.

- Poor adhesion between coats.
- Surface contamination between coats.
- Not abrading or using too-fine of a grit abrasive between finish coats.
- Recoating a cured floor without proper preparation (either chemical or mechanical).
- Applying a subsequent coat of finish after the window to do so without abrasion (hot coating) has elapsed.

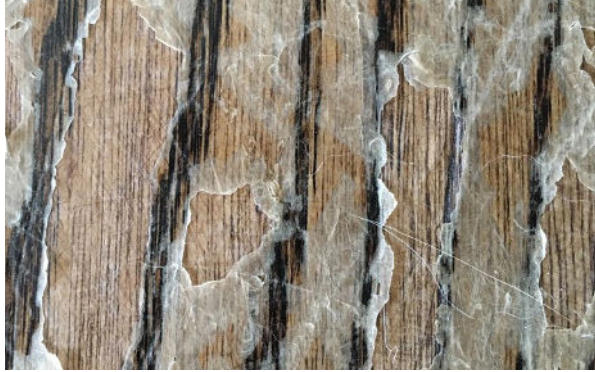
## Finish Adhesion Failure

**Peeling Finish** - The condition that occurs when a dried film of finish separates from the underneath surface in the form of large pieces or sheets.

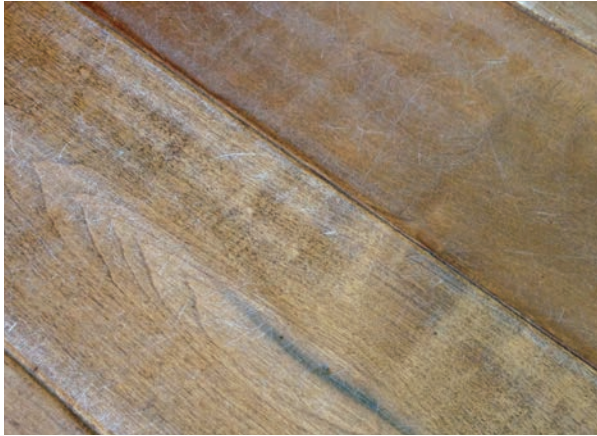
## Finish Wear Discrepancies

**DEFINITION:** The performance of the surface coat of finish not meeting expectations.

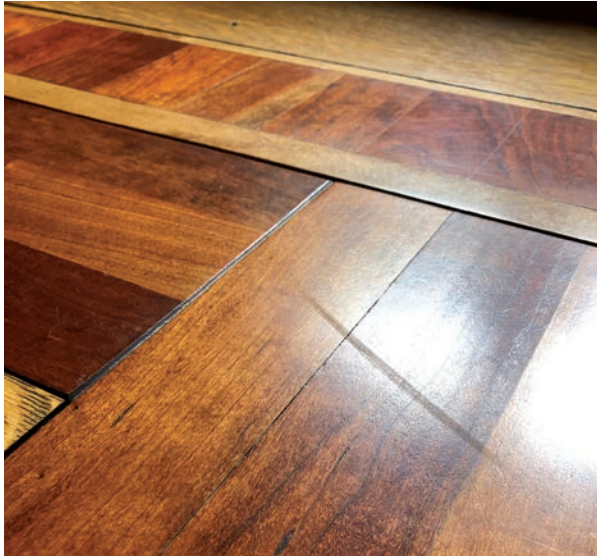
## Scuffing

**DEFINITION:** Marks or abrasions left on a wood floor surface or finish.

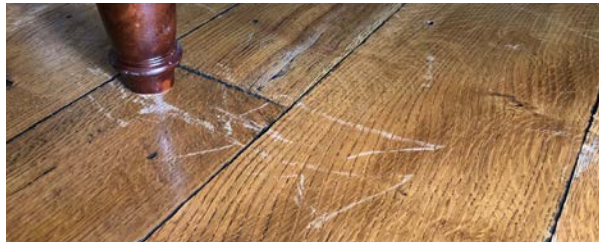
- **Scratches** - caused by applied horizontal and vertical forces.

- Finish systems may be marred or scuffed, either from chemicals or from heat generated by sliding objects across them. These may look like scratches, but are not.
- Surface scratches are typically only in the finish coats. A fingernail can't feel the ridge.
- Deep scratches are typically through the finish coats and have torn the wood fibers.
- Cross-grain scratches are deep scratches, and are oriented perpendicular to the direction of the flooring, often crossing multiple board widths and have a higher probability of exhibiting wood fiber tear. Deep scratches, usually termed "gouges," are typically through the finish coats and have torn the wood fibers.
- As scratch damage increases in severity, so does the likelihood that the damage will also include denting.
- **Indentations** - notches, grooves or depressions on the surface of the flooring.

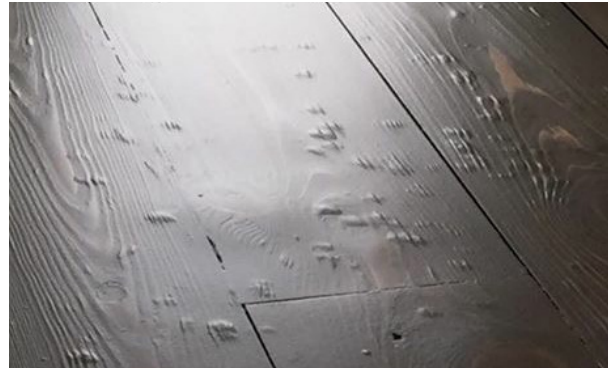
- **Wood bruises** - from a previous force or trauma to the surface of the boards that is not normally noticeable during the installation or handling of the product. This damage can become exposed with an increase in moisture, such as with the introduction of water through water-popping, water-based finishes, water-based stains, or similar reactive conditioners.

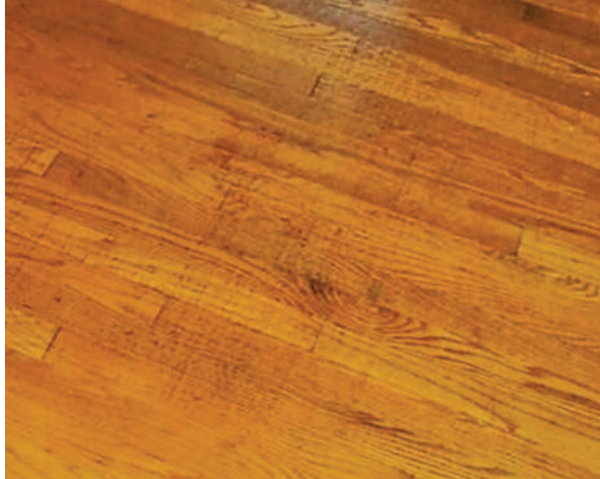
## Surface Impressions

**DEFINITION:** A shape or pattern imprinted on the face of the board, which resembles an item or object that had been in direct contact with it.

- Various rug types or backing materials can leave an imprint in the floor finish system.
- Plasticizer migration from some non-slip backing pads used under area rugs can leave a waffle-like pattern etched into the finish system.
